Retrofit Revisit: 10 Case Studies

Julie Godefroy and Marion Baeli

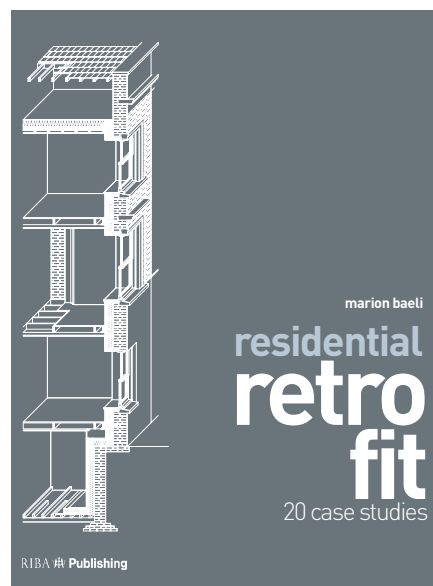
Residential Retrofit (cover)

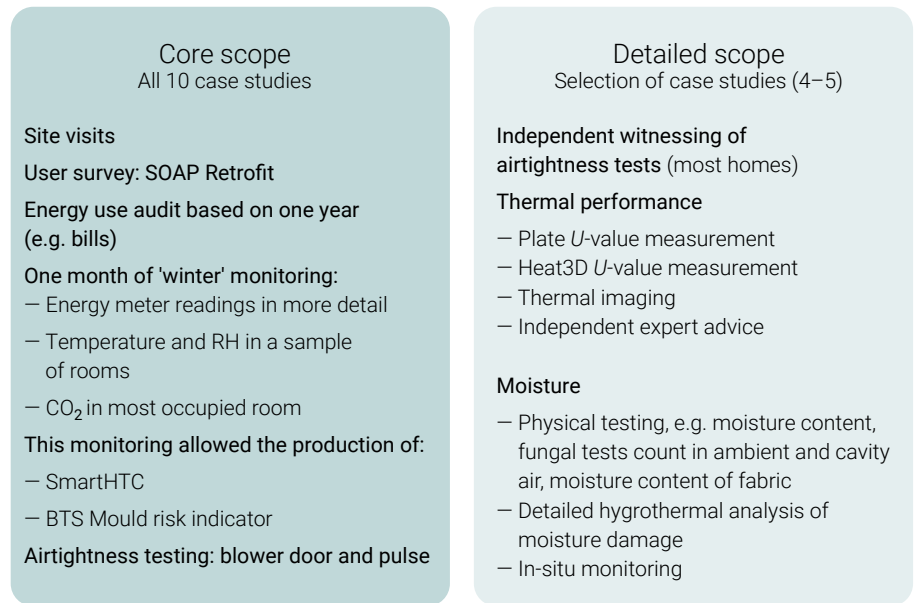
Figure 1.1 Retrofit Revisit 'core' and 'detailed' building performance evaluation scope

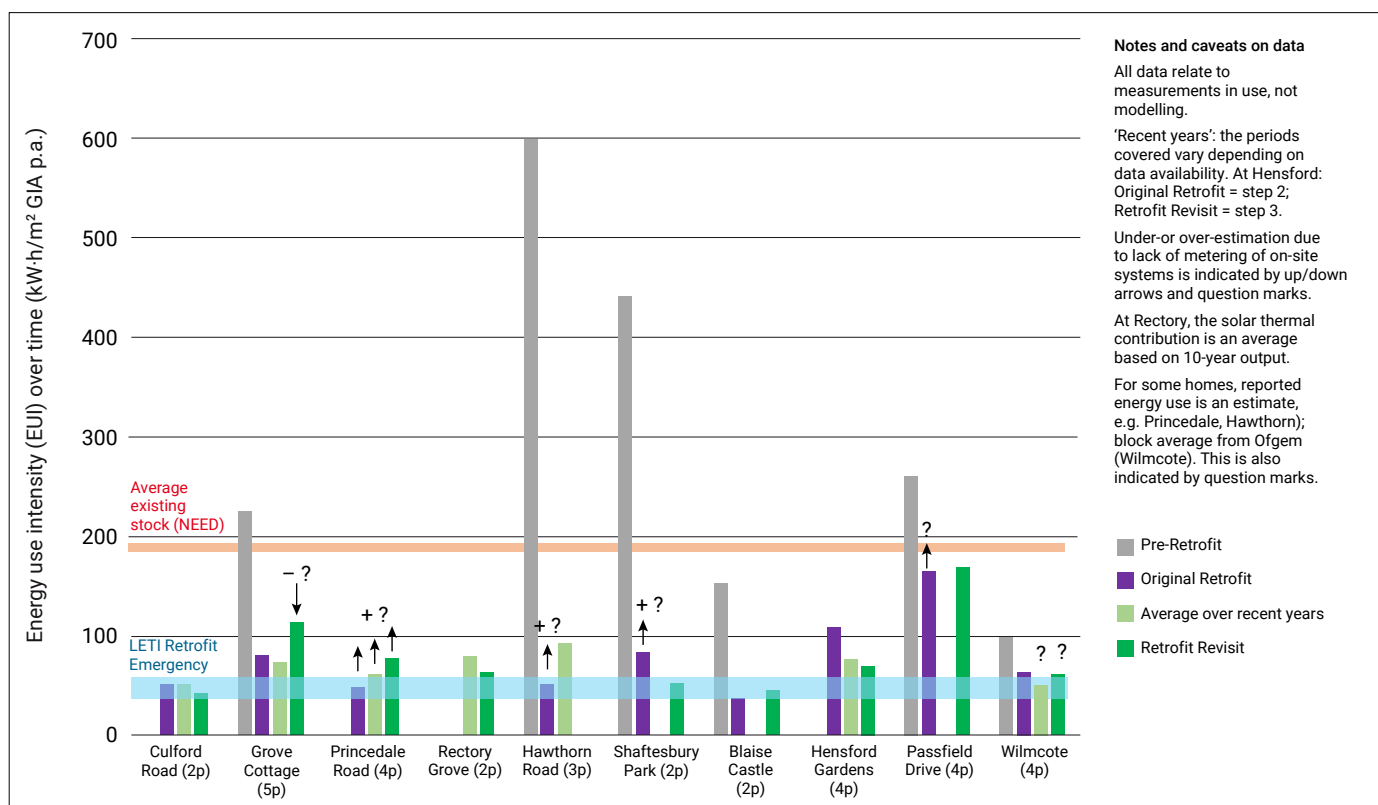
Figure 2.1 Total energy use intensity (EUI) (kWh/m² GIA p.a.)

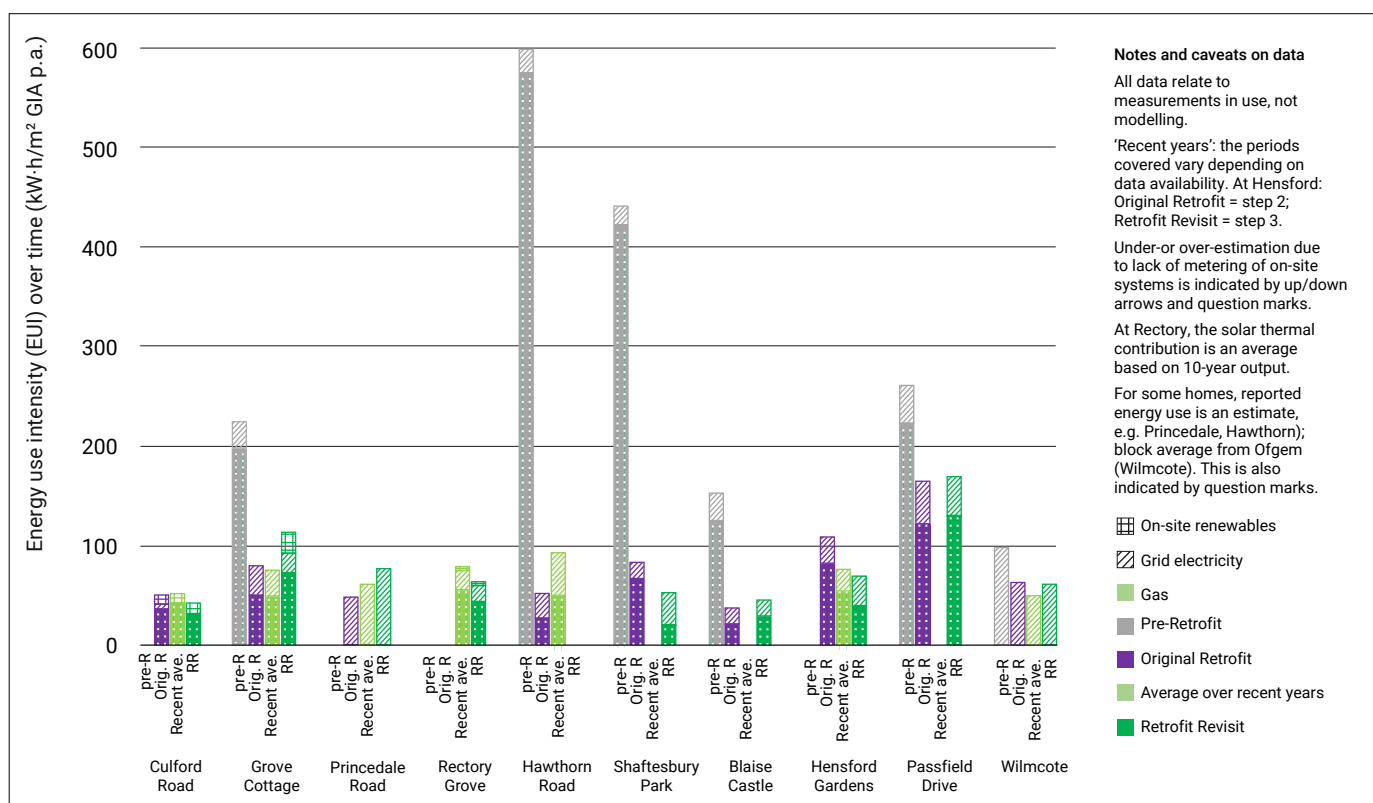
Figure 2.2 Energy use intensity (EUI) broken down into gas and grid/on-site renewable electricity (kW·h/m² GIA p.a.)

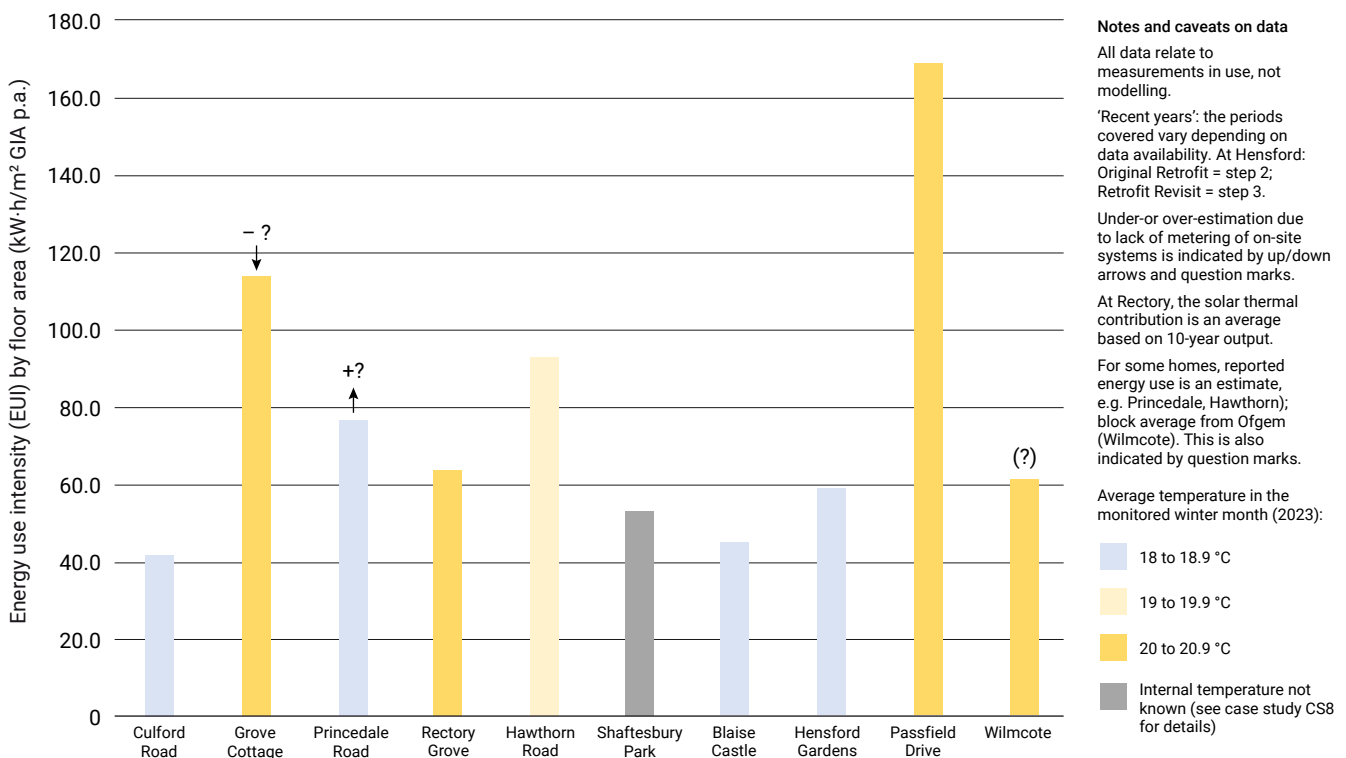
Figure 2.4 Energy use by floor area (kW·h/m² GIA per annum)

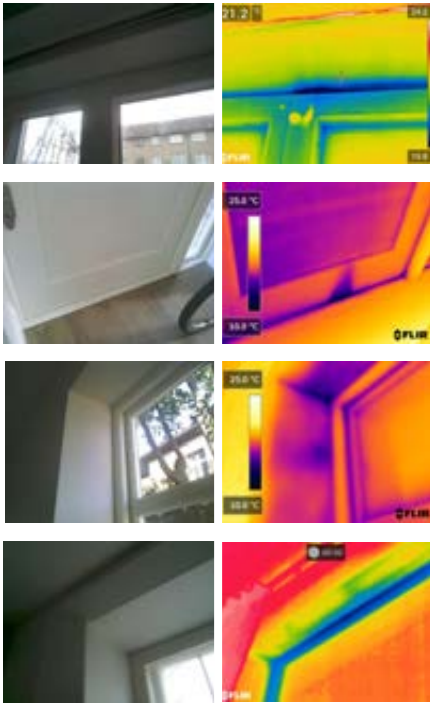
Figure 3.3 Thermal images illustrating the effects of leaky windows and door frame with cold air paths in blue

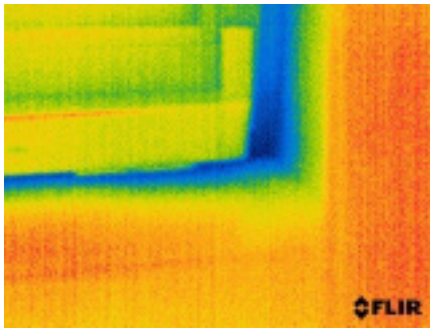
Figure 3.4 Blaise Castle: air leakage at window frame

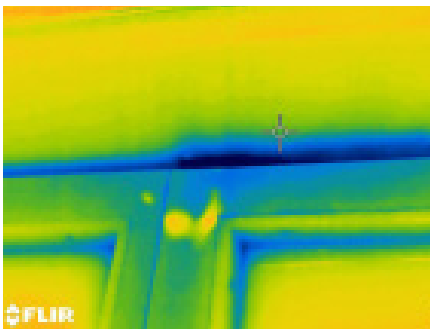
Figure 3.5 Passfield Drive: air leakage at door frame

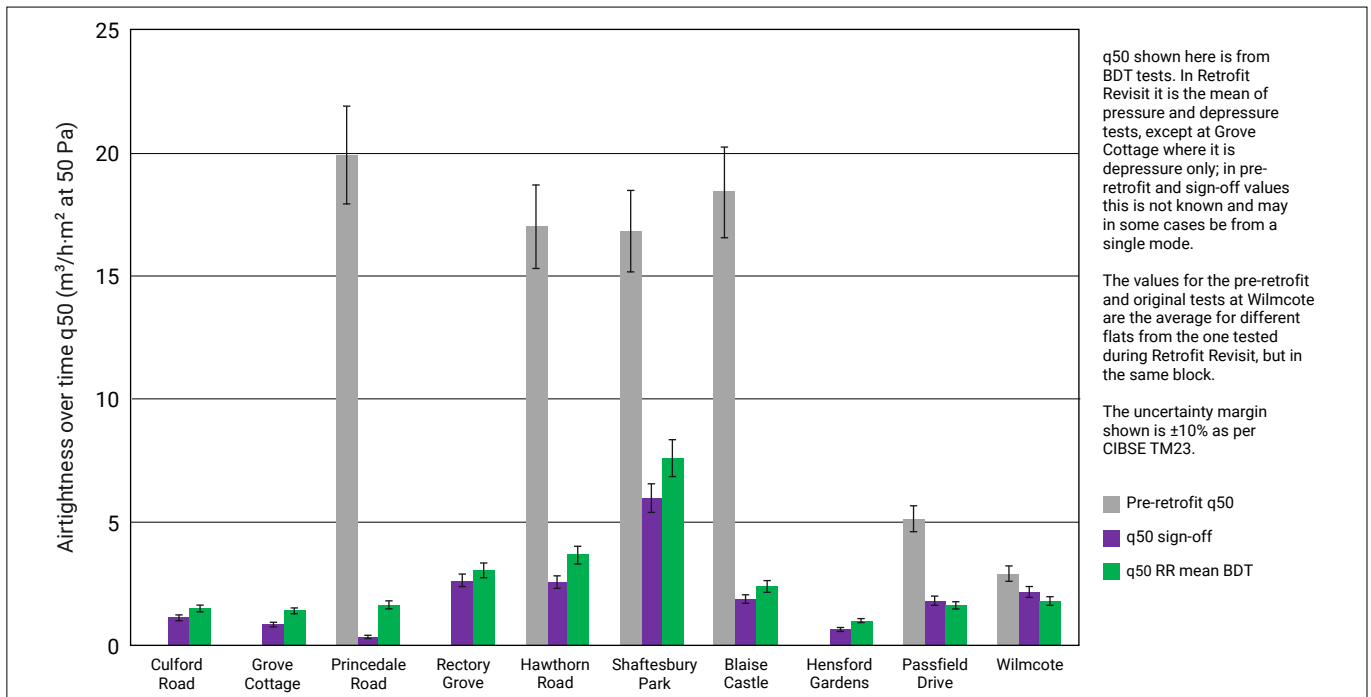
Figure 3.6 Airtightness ($\text{m}^3/\text{h}\cdot\text{m}^2$ @ 50 Pa) q50 over time

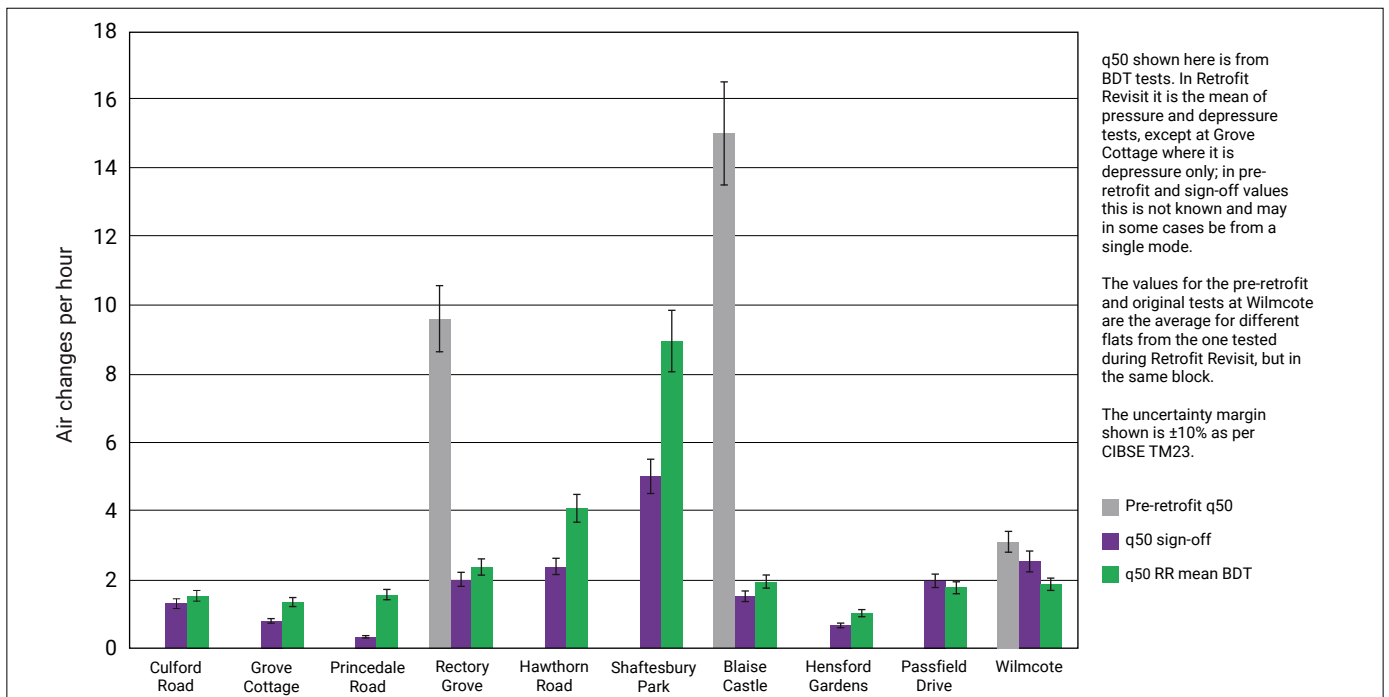
Figure 3.7 Airtightness (air changes per hour) n50 over time

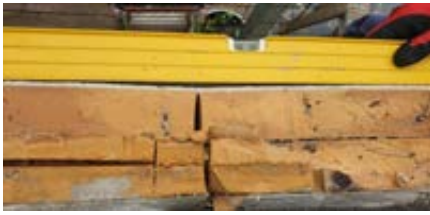
Figure 4.3 Blaise Castle: phenolic insulation board has bowed

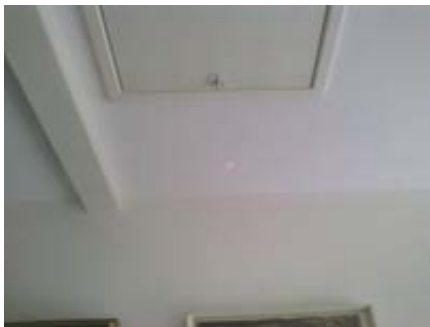
Figure 4.4 Ceiling examined by thermal imaging

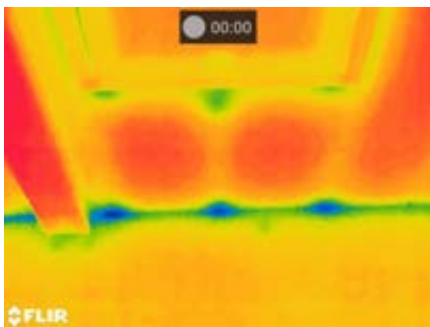
Figure 4.5 Thermal image of the ceiling shown in Figure 4.4

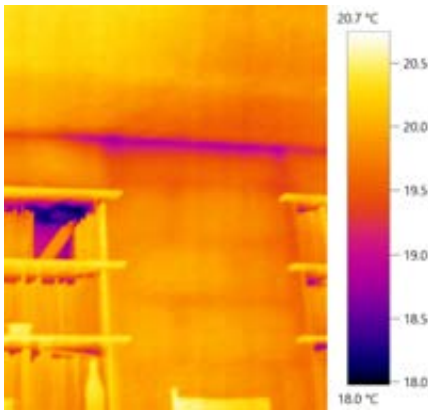
Figure 4.10 Infrared image of visible dampness in the living room of Culford Road

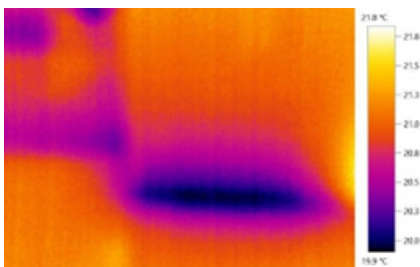
Figure 4.12 Thermal image of the damp area shown in Figure 4.11

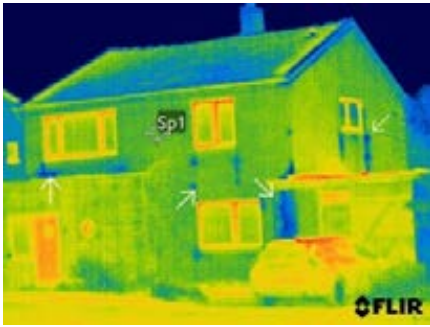
Figure 4.13 Blaise Castle: infrared image of front (west) and side (south) elevations (arrows indicate surface condensation with run-off from aluminium sills and interface with car port roof; this finding is subject to further investigations to confirm the cause)

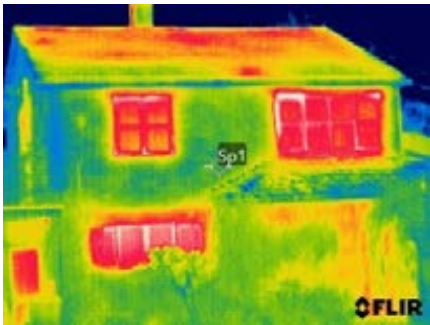
Figure 4.14 Blaise Castle: IR image of neighbouring house (not retrofitted) for comparison

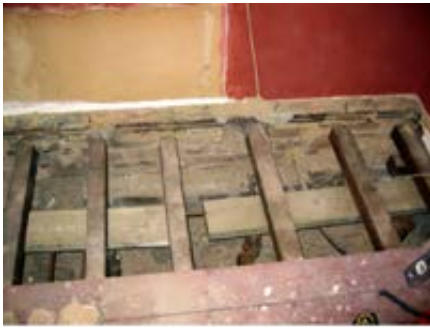
Figure 4.15 Shaftesbury Park: pre-retrofit ground floor and joists

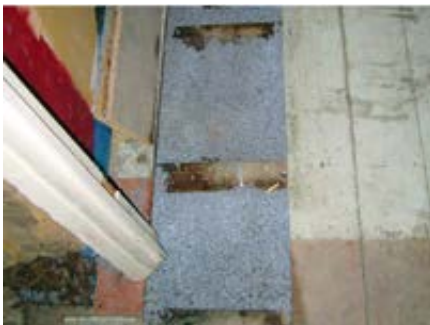
Figure 4.17 Shaftesbury Park: EPS bead infill between floor joists

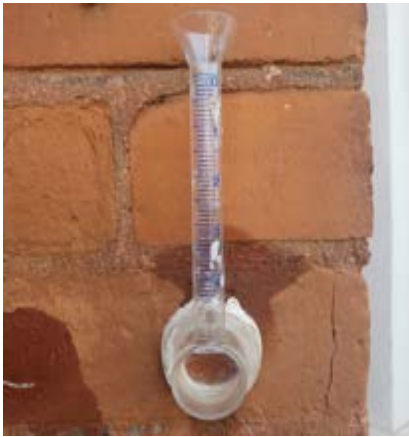
Figure 5.3 Karsten tube test for testing the porosity of the brick

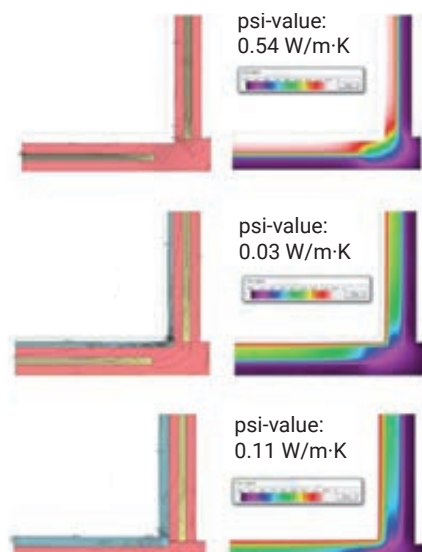
Figure 5.5 Hensford Gardens thermal bridge modelling

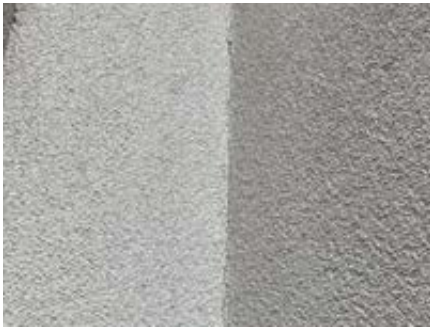
Figure 5.6 Minor hair line crack in external wall insulation (EWI) top render

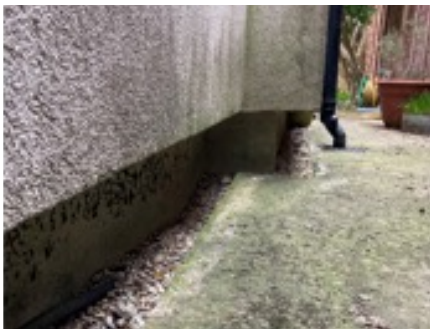
Figure 5.7 Slight staining of the EWI render

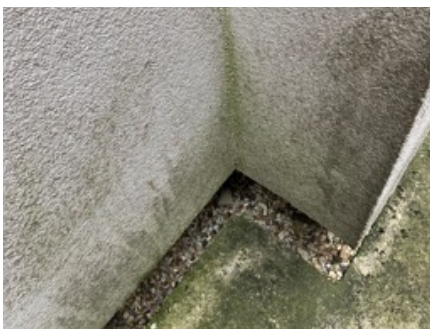
Figure 5.8 Slight staining of the EWI render and traces of moss

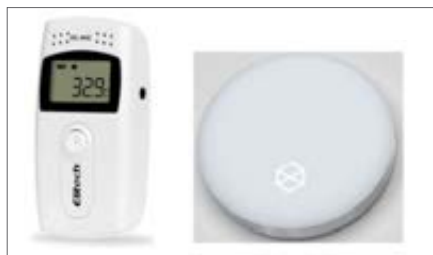
Figure 6.1 Temperature and RH sensors used in the Retrofit Revisit case study homes

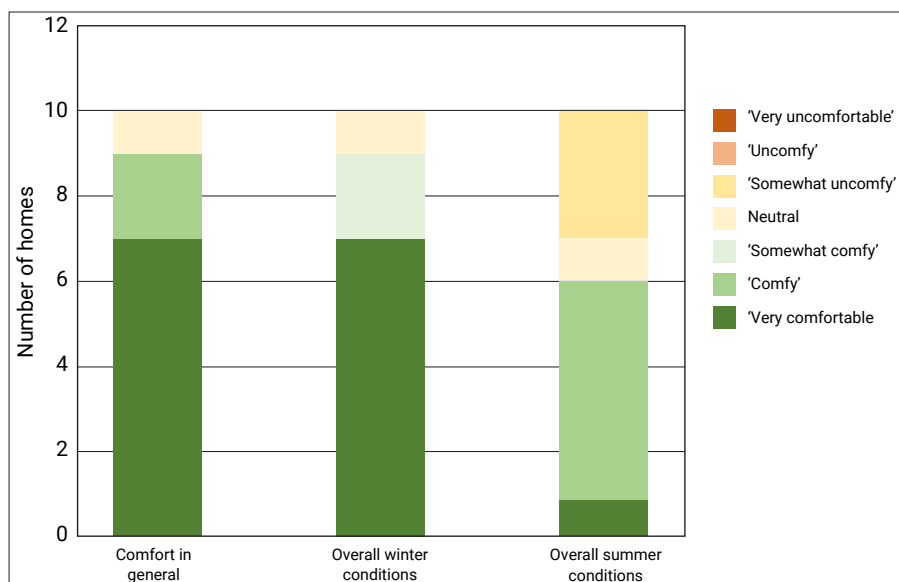
Figure 6.2 Feedback received on thermal comfort across the Retrofit Revisit case studies

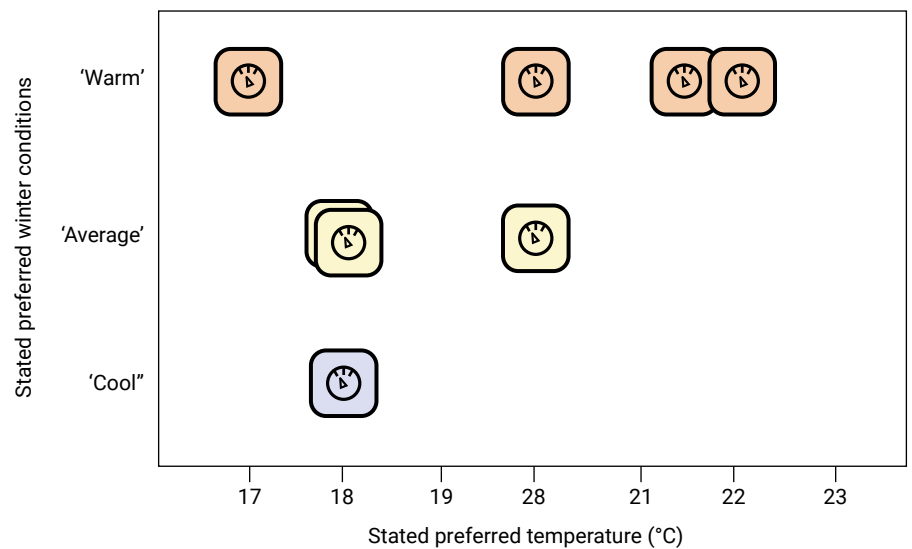
Figure 6.3 Feedback received from residents on preferred winter conditions versus stated preferred temperature

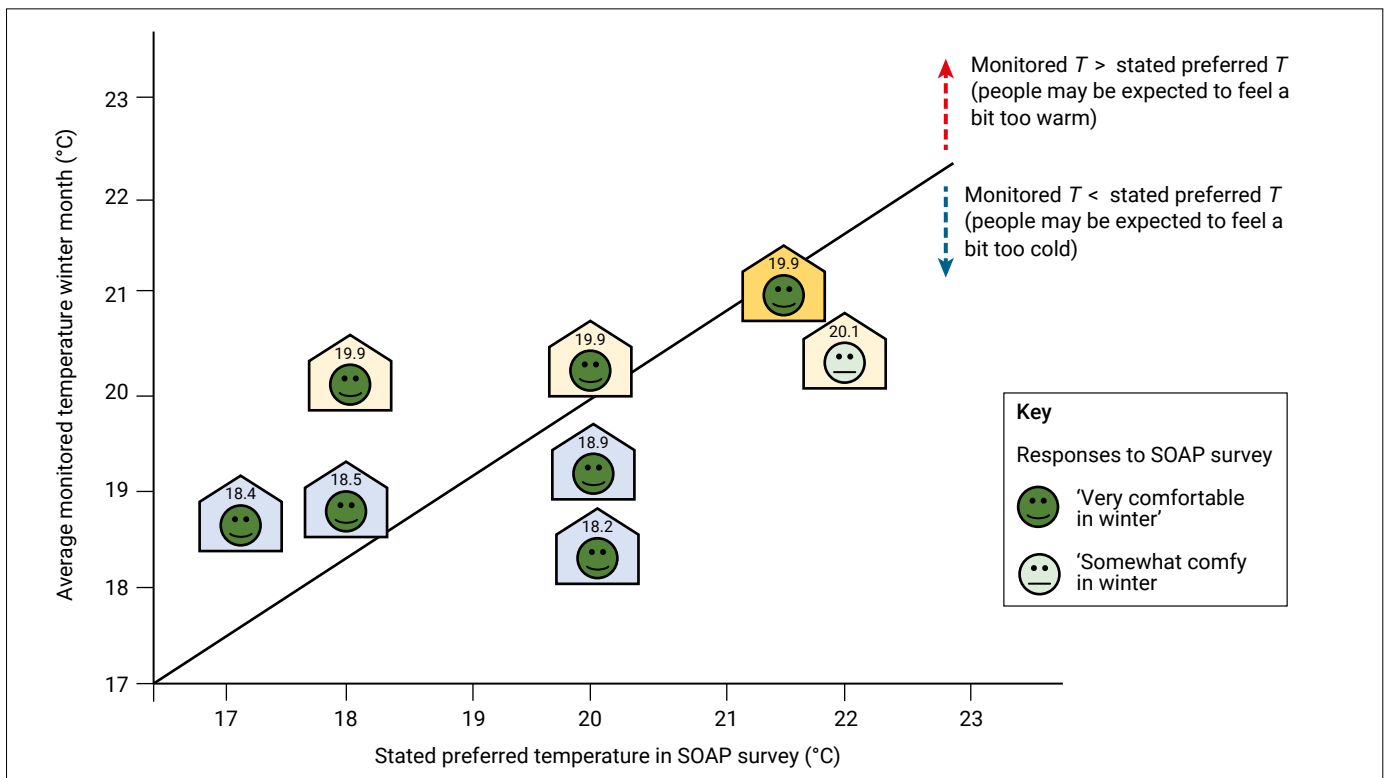
Figure 6.4 Feedback received from residents on preferred temperature and thermal comfort, versus average monitored temperature

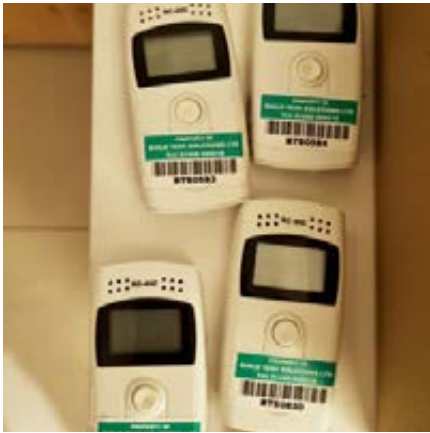
Figure 6.5 Temperature and relative humidity sensors as installed in several locations within each house

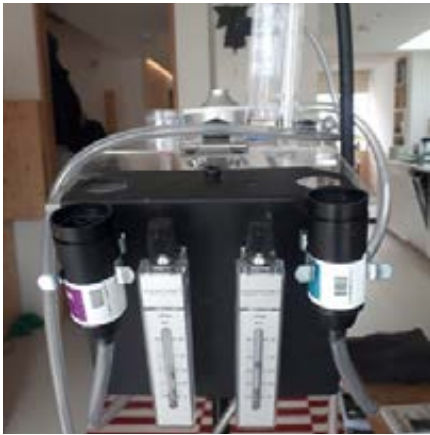
Figure 6.6 Build Test Solution's ambient air humidity sensor equipment

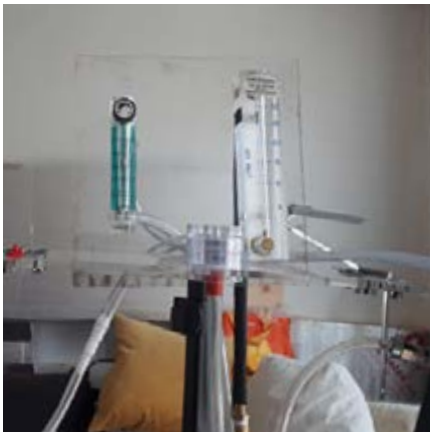
Figure 6.7 Build Test Solution's ambient air humidity sensor equipment

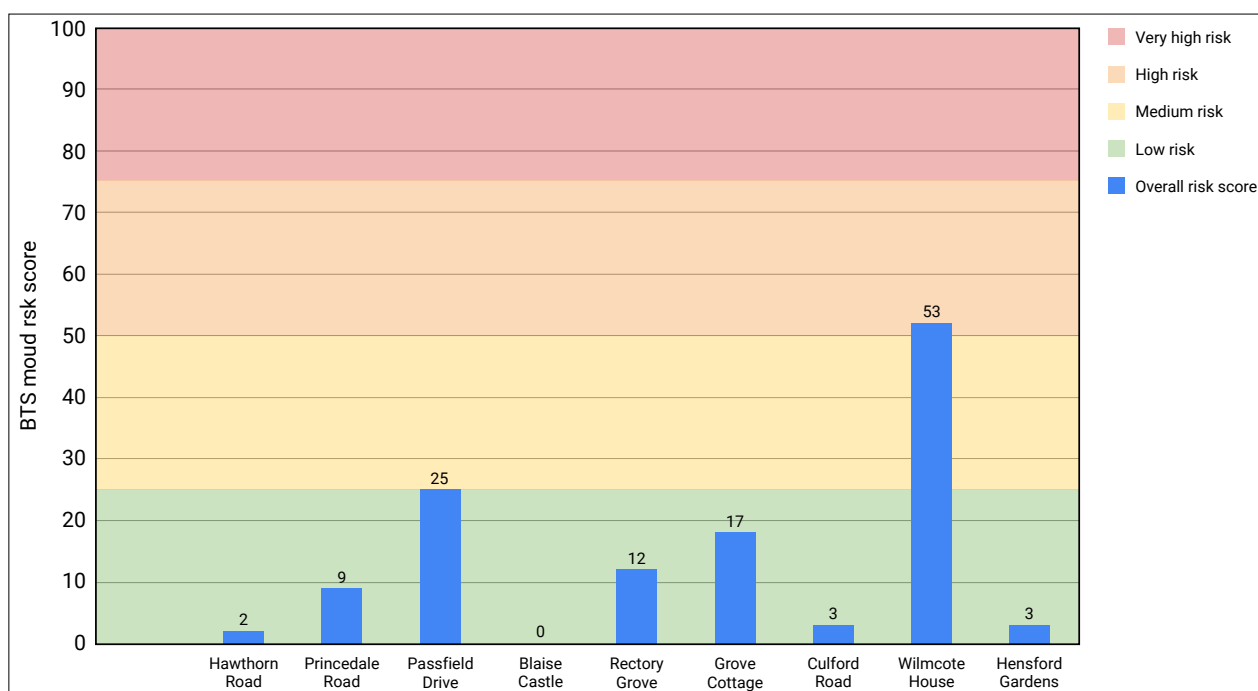
Figure 6.8 BTS mould risk score (March 2023)

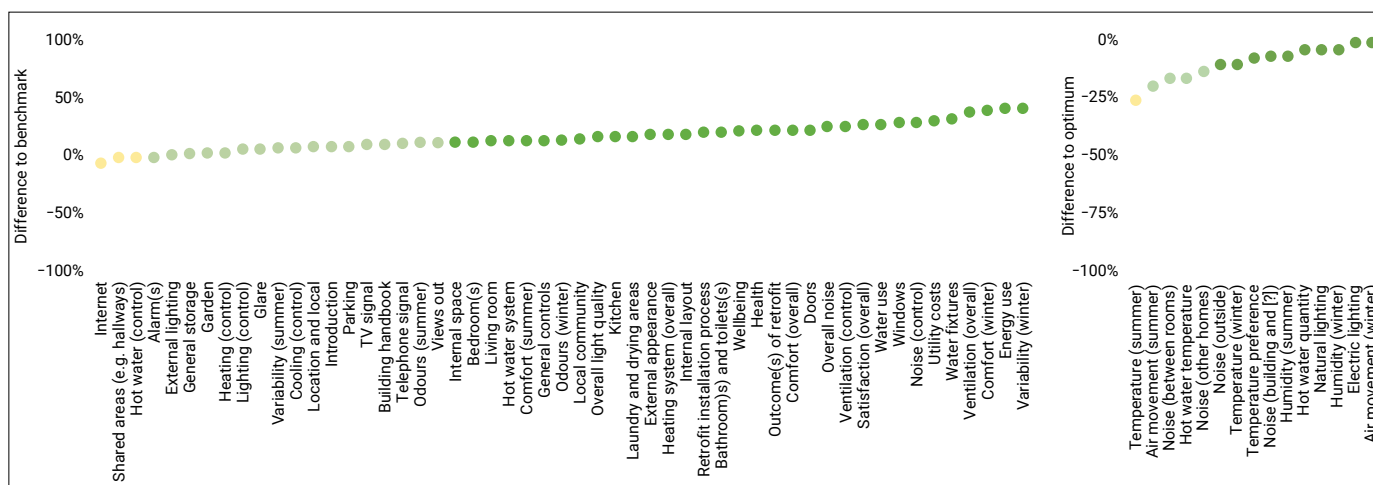
Figure 7.1 Results to SOAP survey questions across the Retrofit Revisit sample

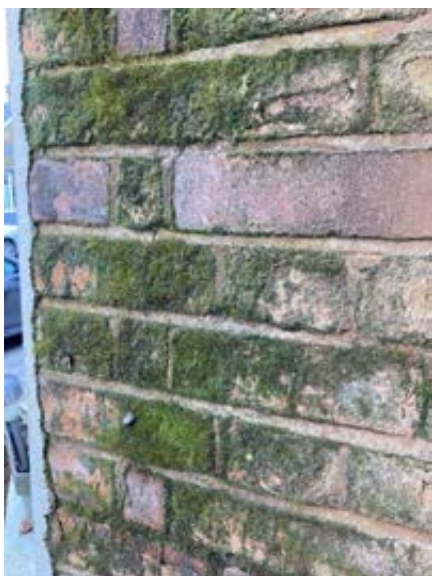
Figure 8.1 Hawthorn Road: moss on brick wall by leaky gutter

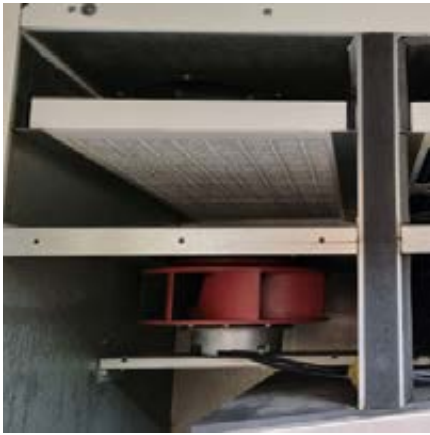
Figure 8.2 Princedale Road: MVHR fan and filters, left hand fan has been replaced after functioning for 11 years

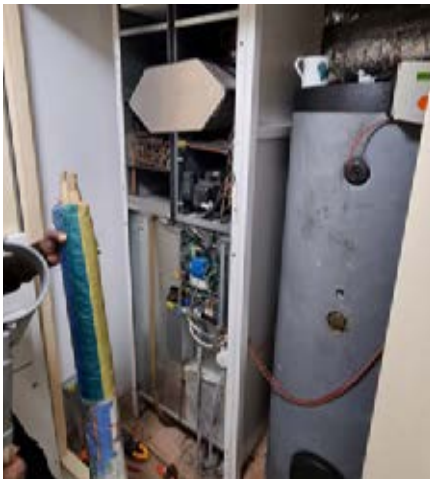
Figure 8.3 Princedale Road: GenvexCombi providing hot water and fresh air supply throughout the house; set behind acoustic doors

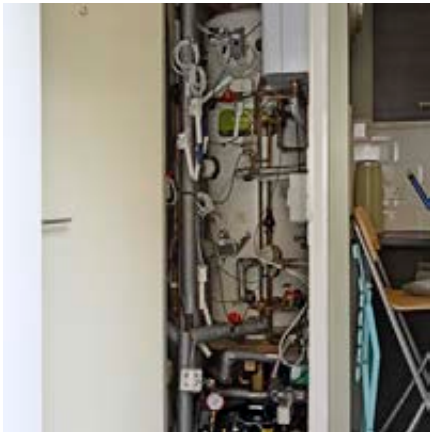
Figure 8.4 Shaftesbury Park: ventilation and hot water production system. The installation was an experiment and unfortunately did not pass the test of time and failed, mostly due to lack of maintenance

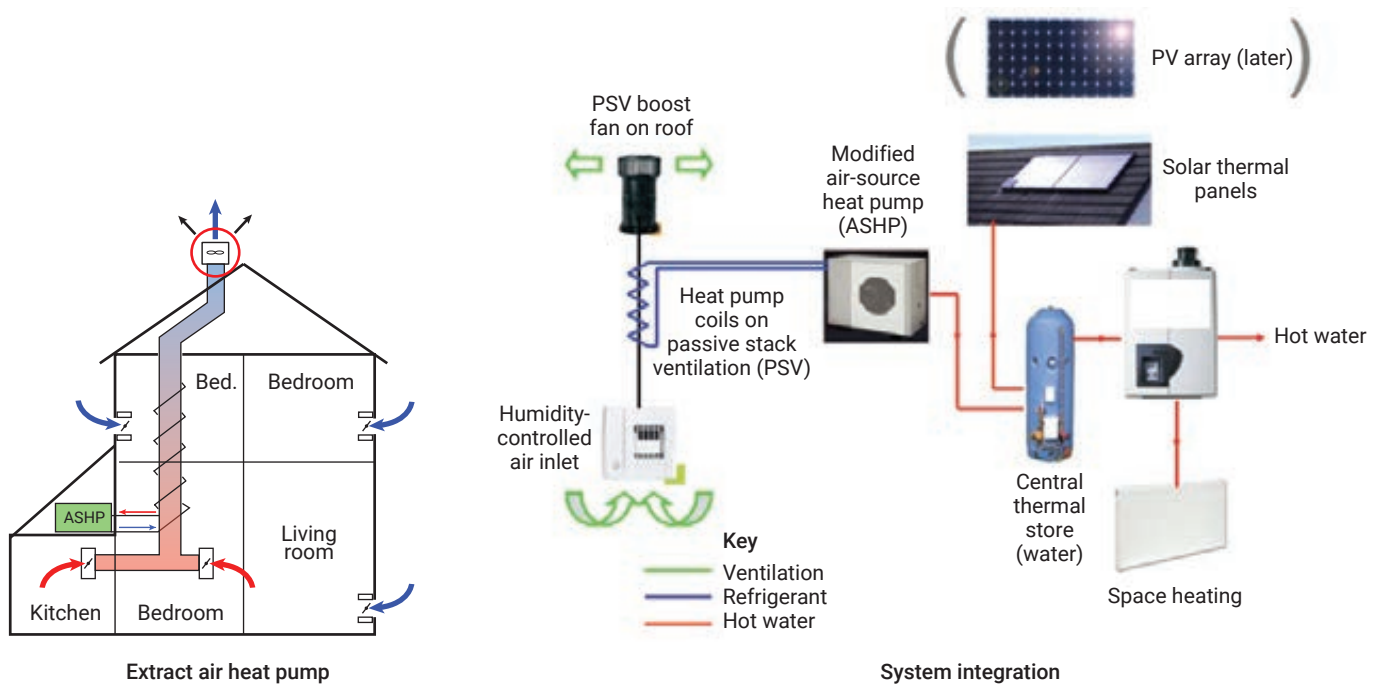
Figure 8.5 Shaftesbury Park: ventilation and hot water production system schematic

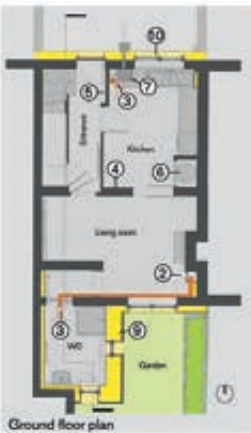
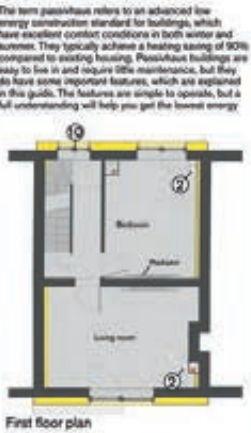
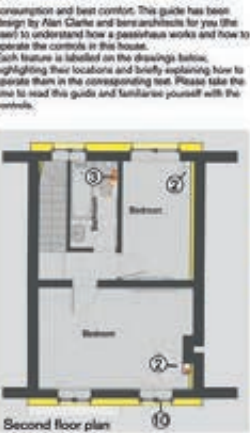
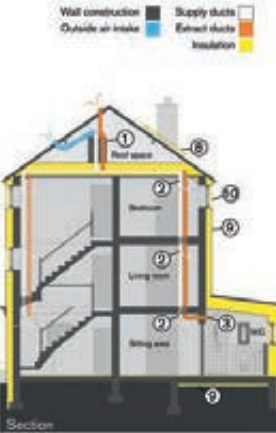
1 Heat recovery ventilation unit
Provides continuous fresh air to the rooms, and saves heat from bathrooms and kitchens to warm fresh air for living and bedrooms. The system saves about 10 times more energy than if used if it is located in the roof space. The filter needs changing every 3 months in London because the air is so dirty.

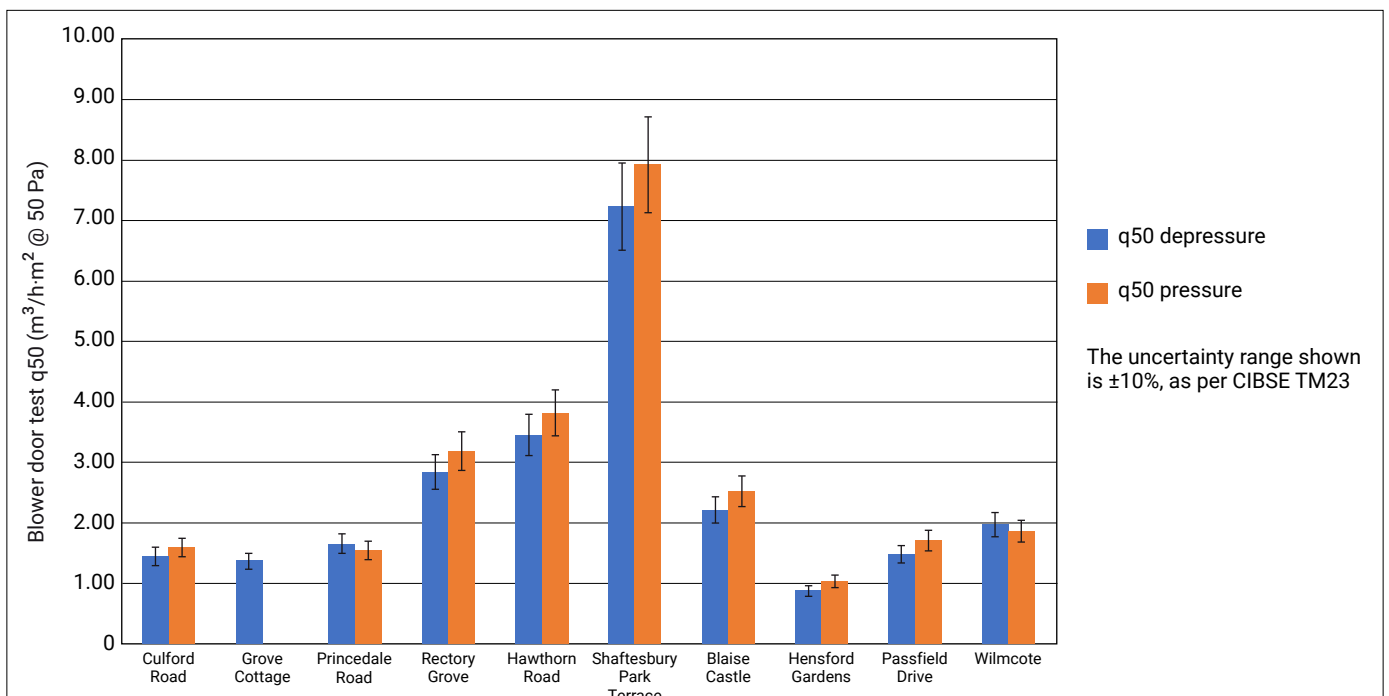
Figure 9.2 Pressurisation and depressurisation results

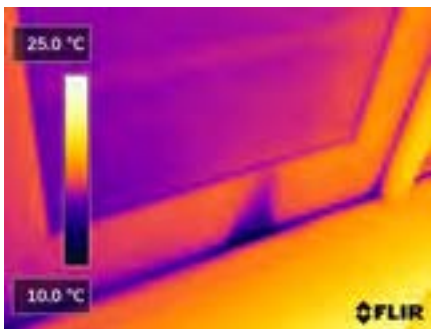
Figure 9.3 Princedale Road: air path under door due to failing door seal revealed by thermal imaging

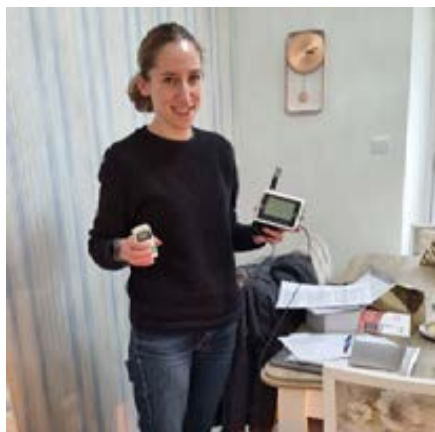
Figure 10.1 Evaluator installing monitoring equipment in Princedale Road

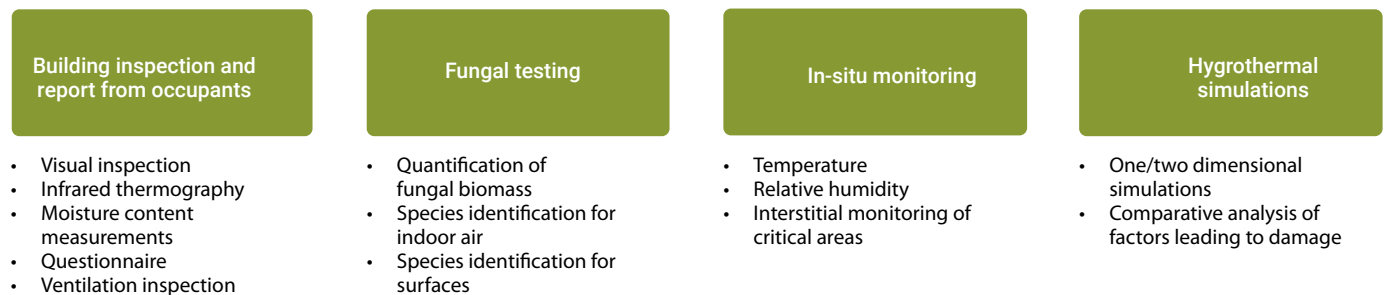
Figure 10.2 Need for an integrated approach on moisture

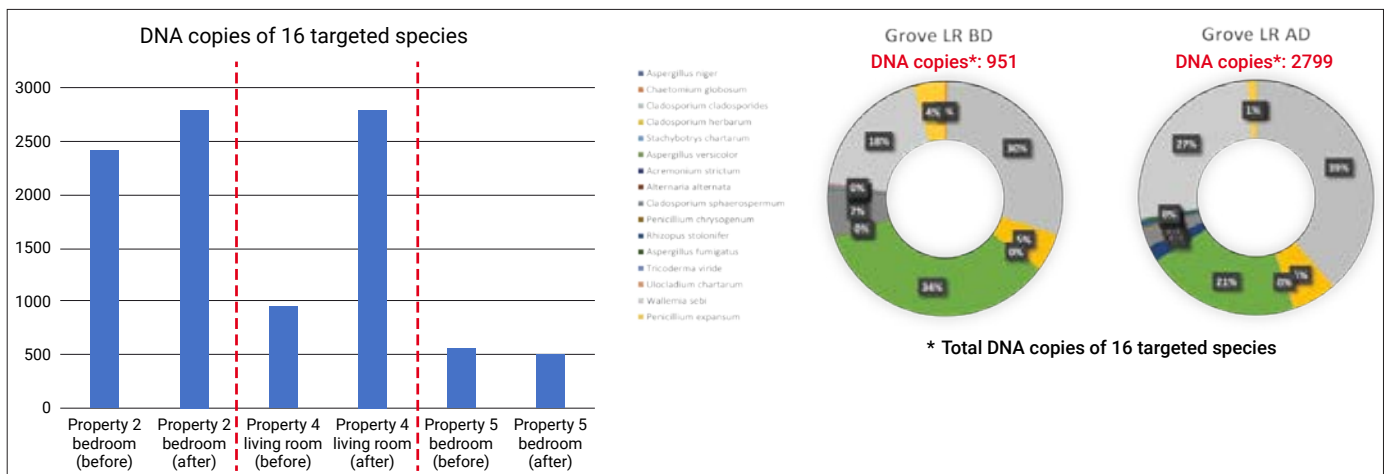
Figure 10.3 Comparison of air sampling before and after depressurisation

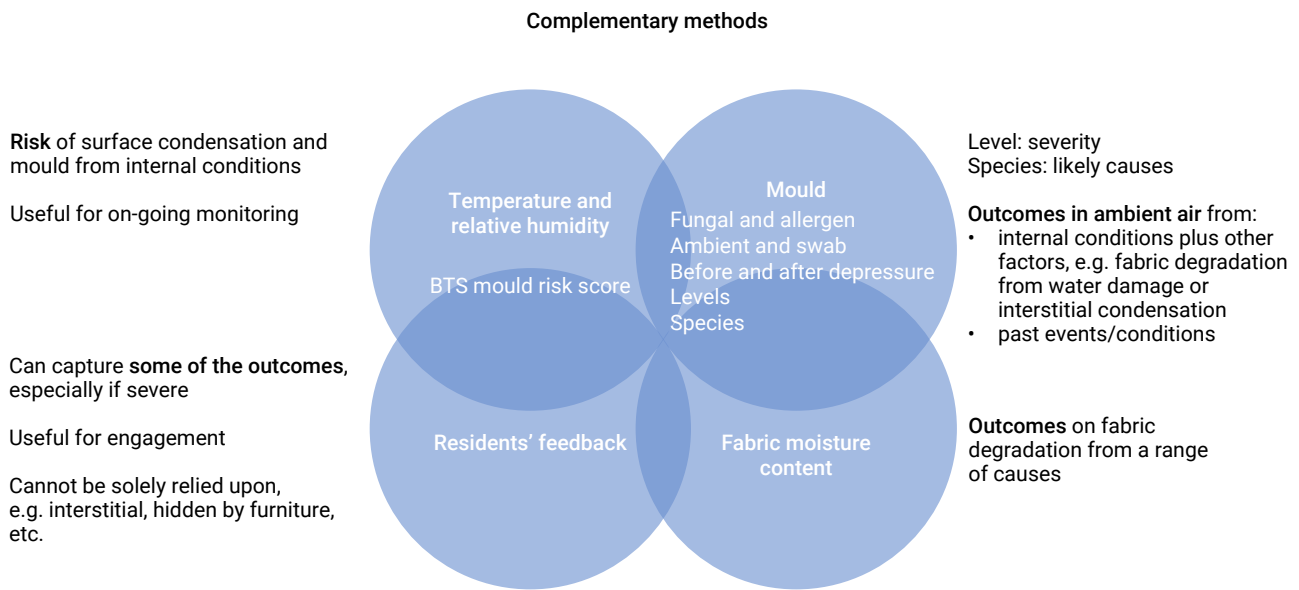
Figure 10.4 Moisture and mould: testing and risk techniques

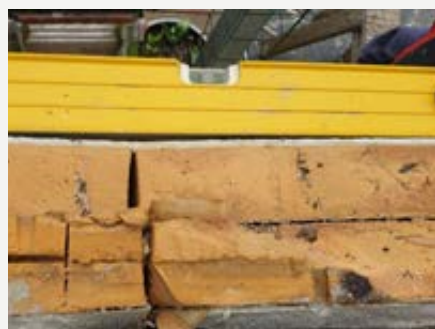
Figure CS1.3 Recent exposure of EWI (April 2023) above balcony section undergoing repairs

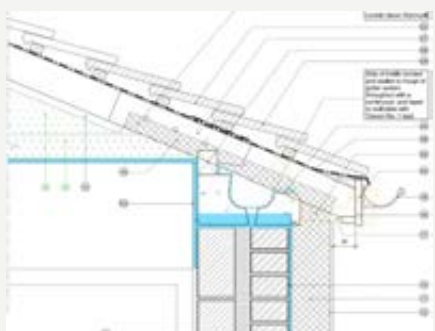
Figure CS1.4 Retrofit treatment

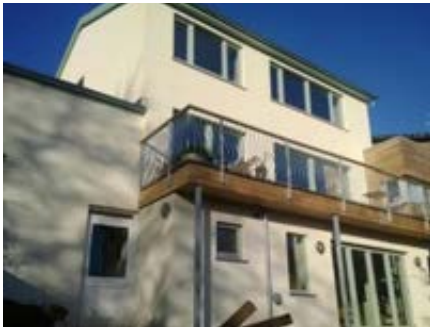
Figure CS1.7 Rear elevation with external wall insulation and balcony

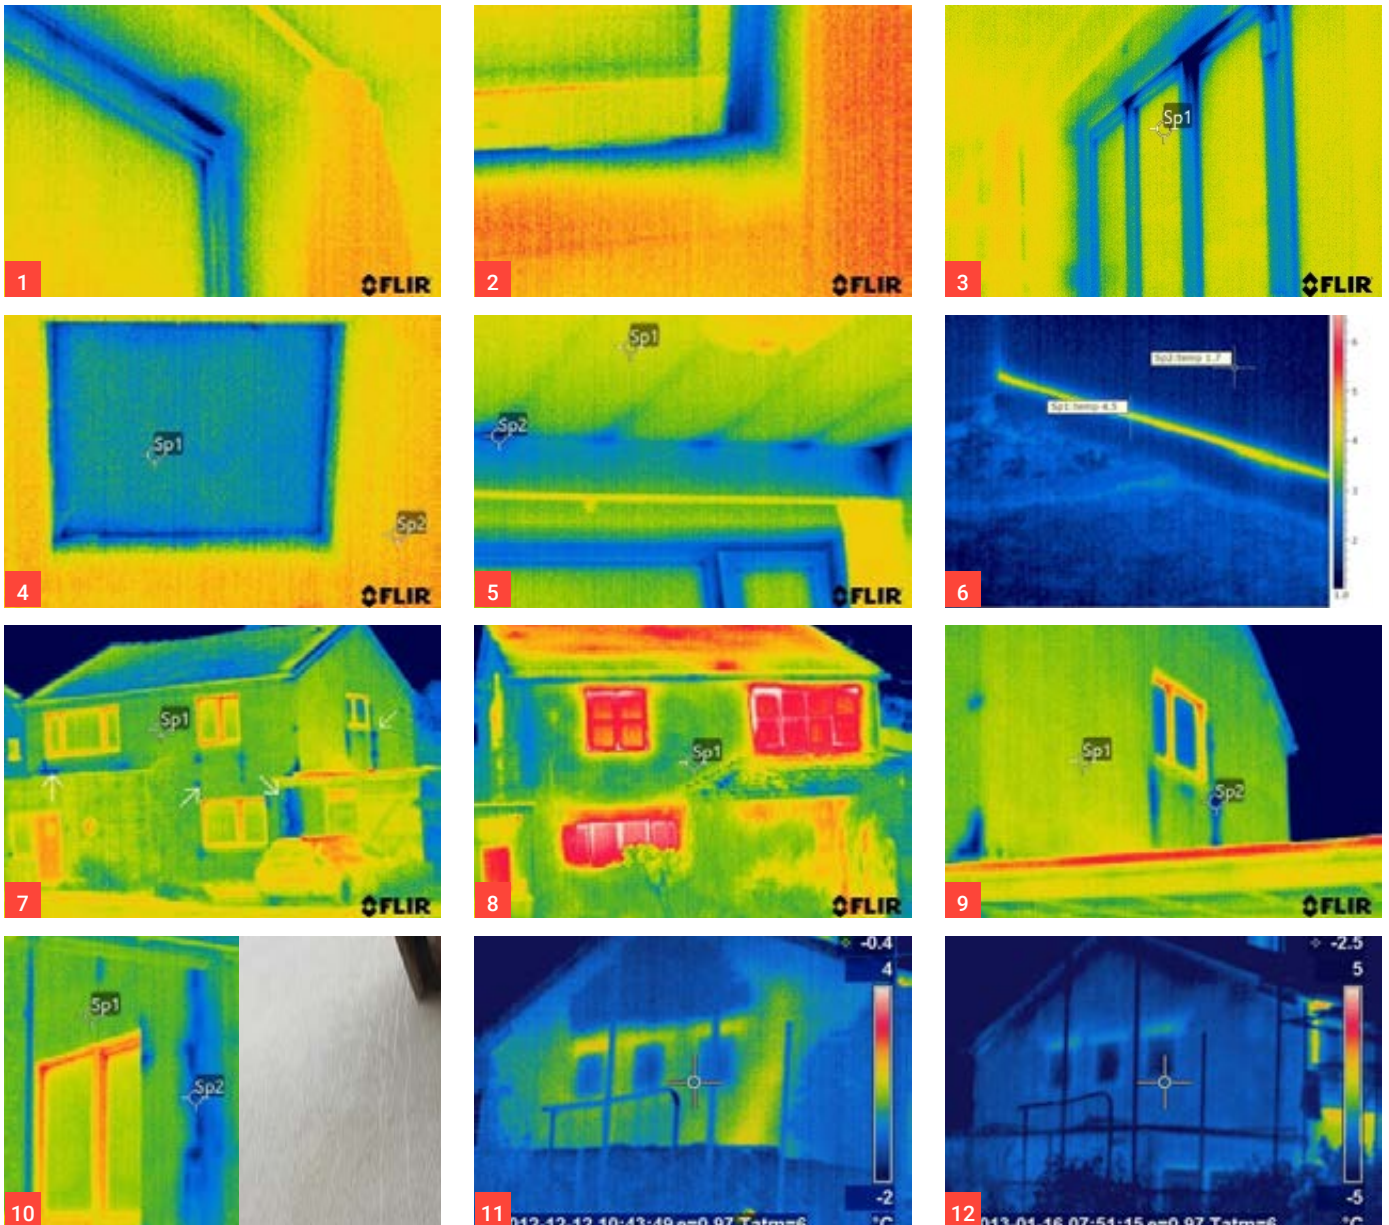
1: Air leakage through top seal on tilt/slide door during depressurisation

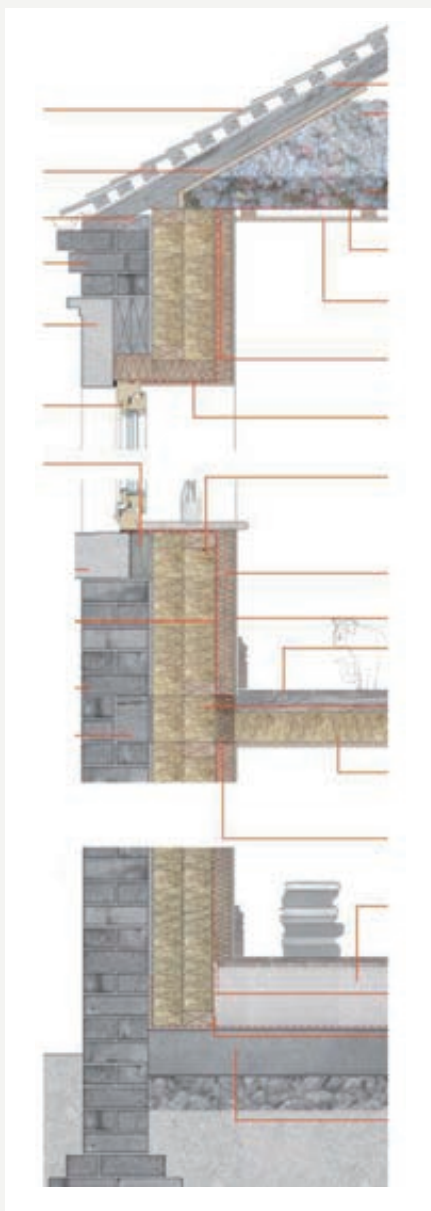
Figure CS2.1 Front elevation section illustrating the wood fibre airtight membrane and sheeps' wool internal wall insulation.

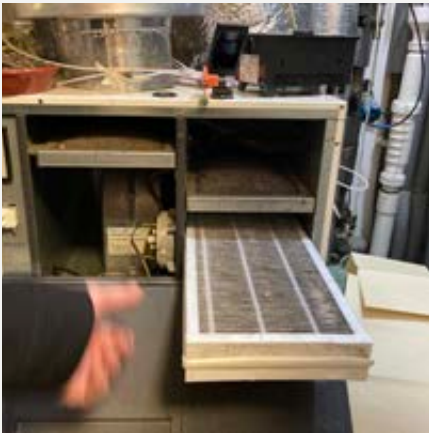
Figure CS2.2 The MVHR filter is being replaced, revealing an abundance of particulate matter and dust accumulated over an extended period since the last replacement

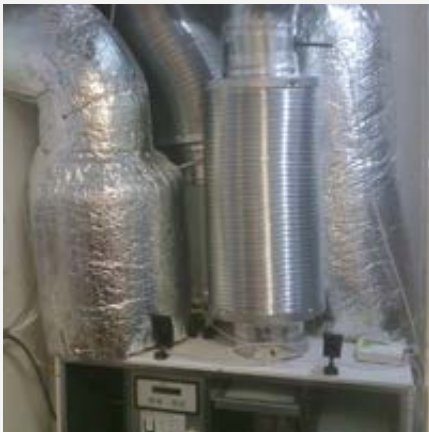
Figure CS2.3 MVHR unit with primary ducts insulated

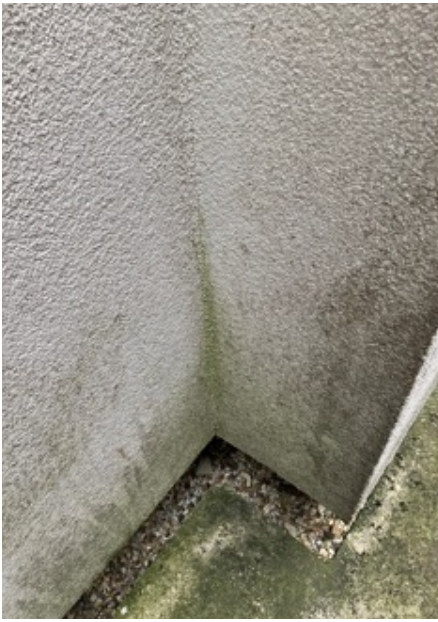
Figure CS2.4 Light moss and weathering on external wall insulation render

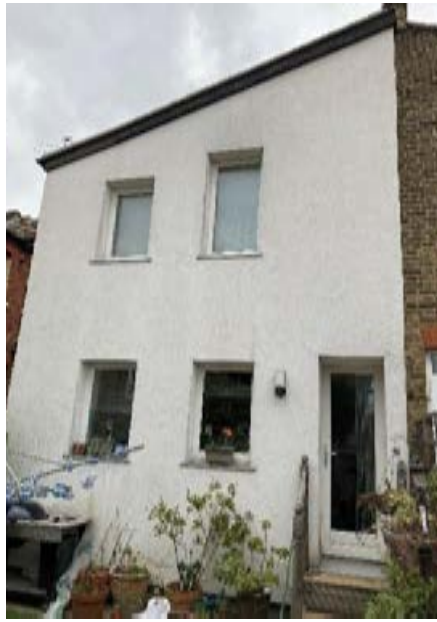
Figure CS2.5 Rear elevation external wall insulation in good condition with very few hairline cracks in render
