Retrofit Revisit: 10 Case Studies

Julie Godefroy and Marion Baeli

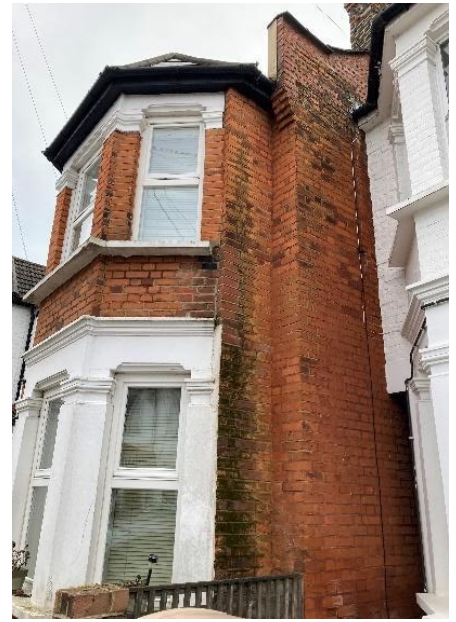
Figure CS2.6 Front elevation showing impact of leaky gutter on brickwork

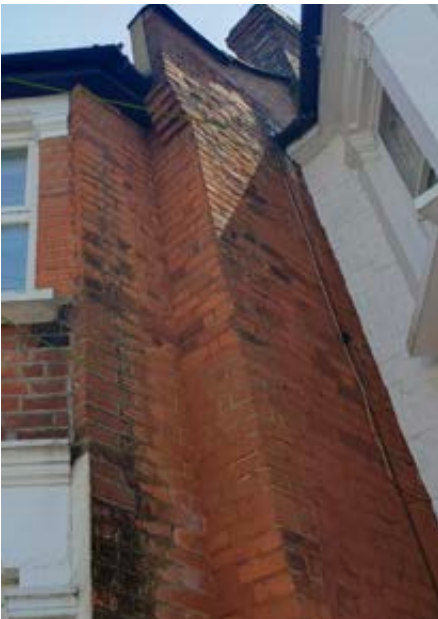
Figure CS2.7 Freeze-thaw damage at high level as a result of faulty rainwater goods, primarily exacerbated by inappropriate cement pointing. Cryptoflorescence visible. The IWI may be increasing the risk, but to a lesser degree than the cement

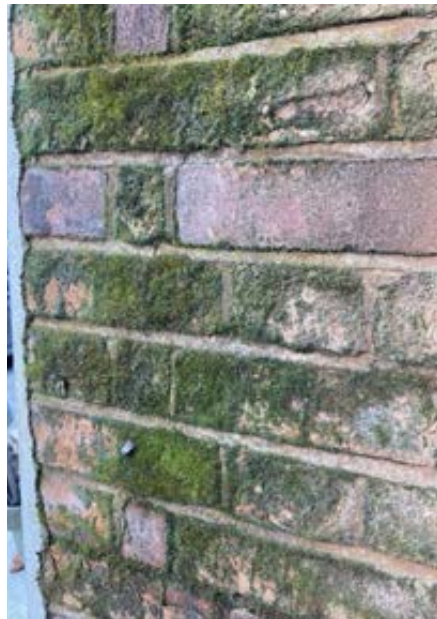
Figure CS2.8 Moss growing on brickwork due to excessive moisture exposure

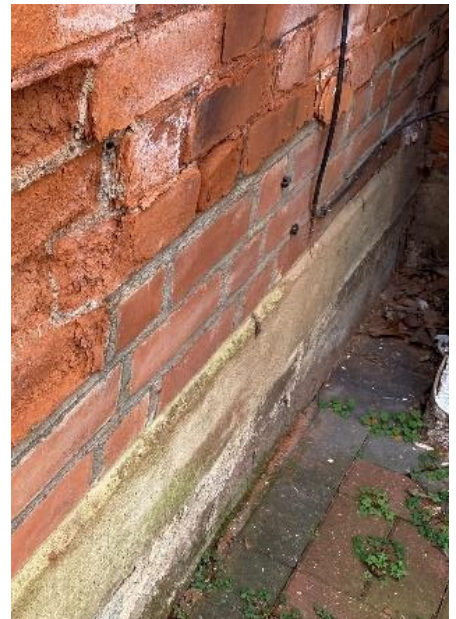
Figure CS2.9 Salt crystallisation damage near to ground level as a result of rising damp (likely linked to the floor treatment), primarily exacerbated by inappropriate use of cement (and possibly impermeable paint)

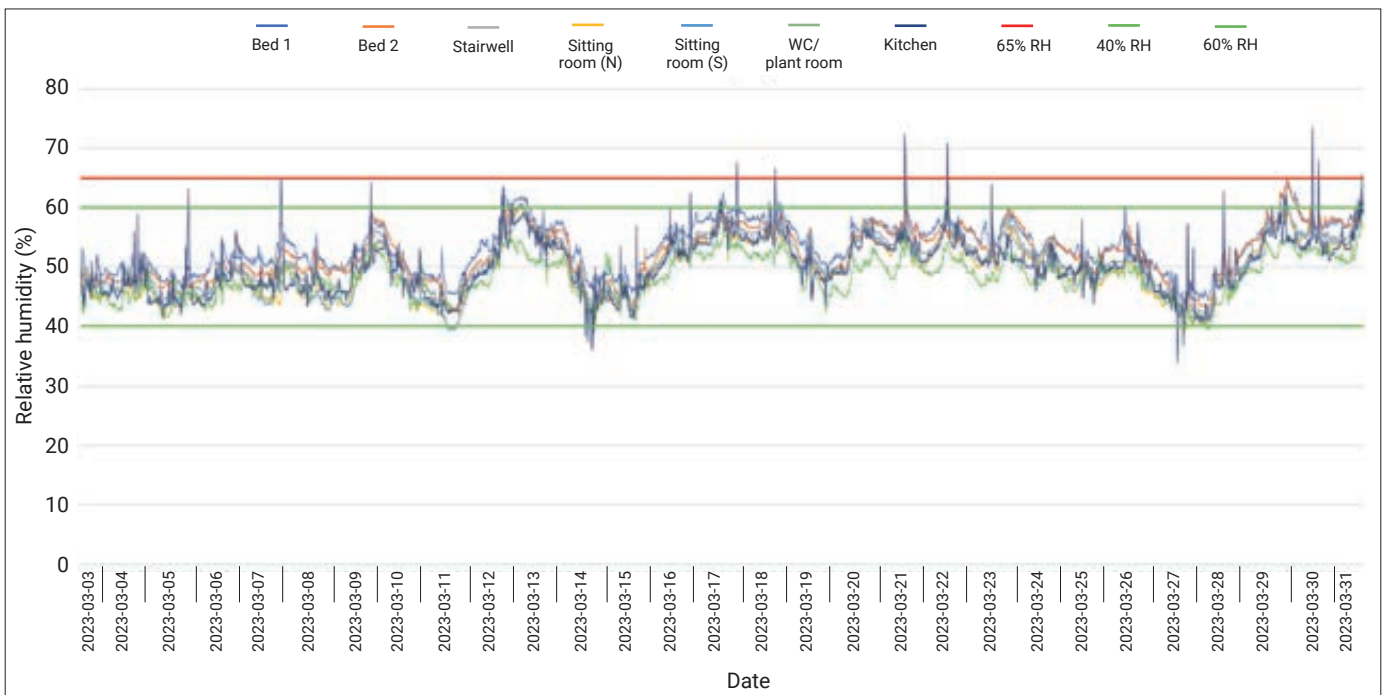
Figure CS2.13 Hawthorn Road relative humidity (%) during March 2023

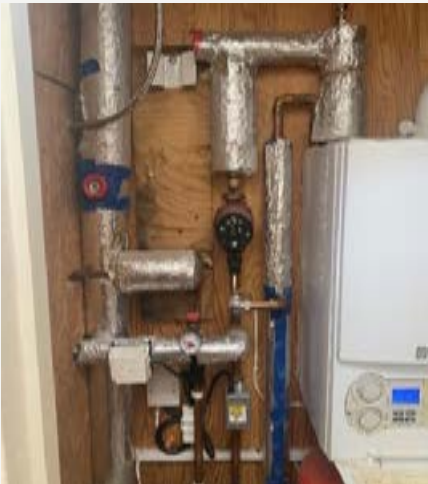
Figure CS3.2 Insulated pipes throughout the property

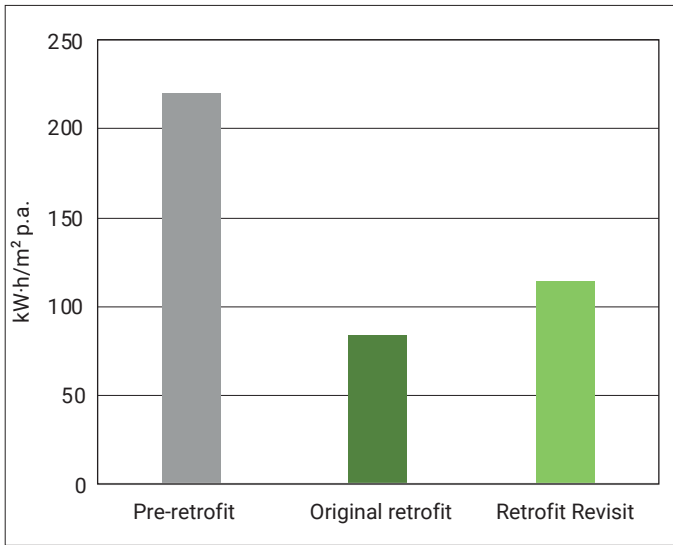
Figure CS3.3 Energy use intensity (kW·h/m² p.a.)

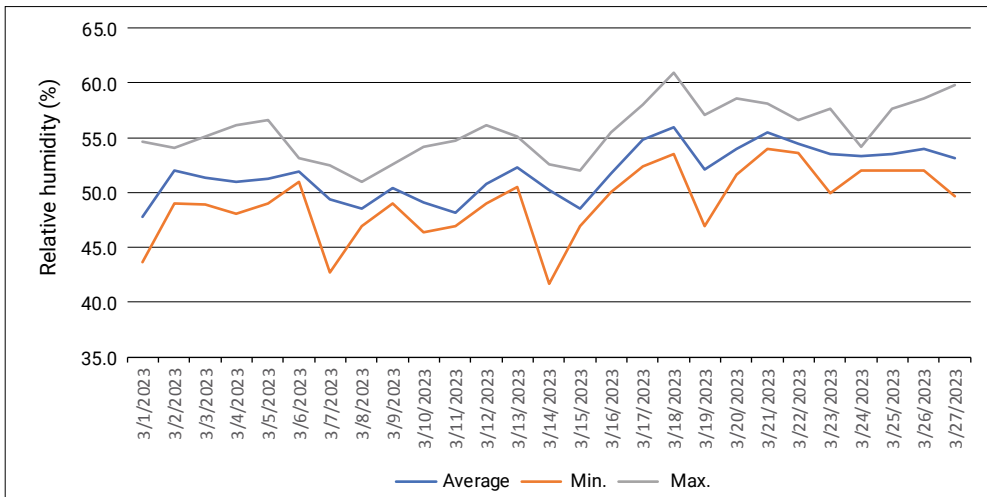
Figure CS3.6 Daily relative humidity (%) in living room

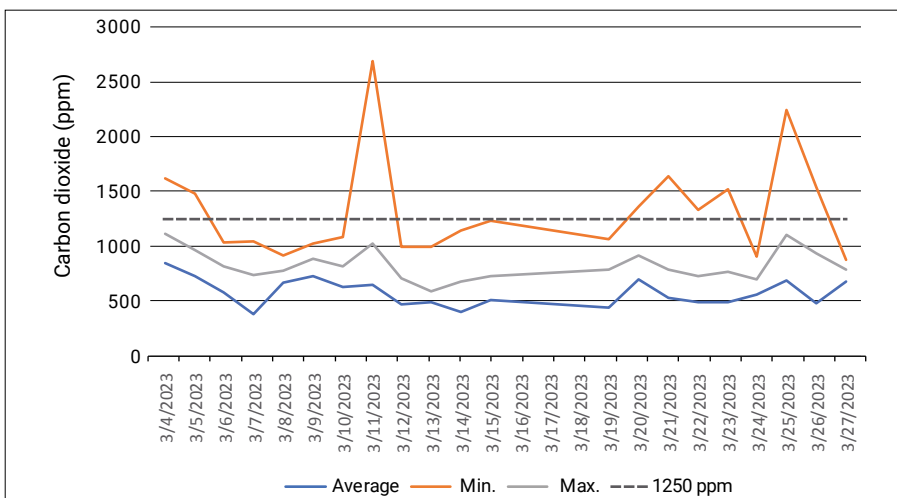
Figure CS3.7 Daily carbon dioxide levels (ppm) in living room

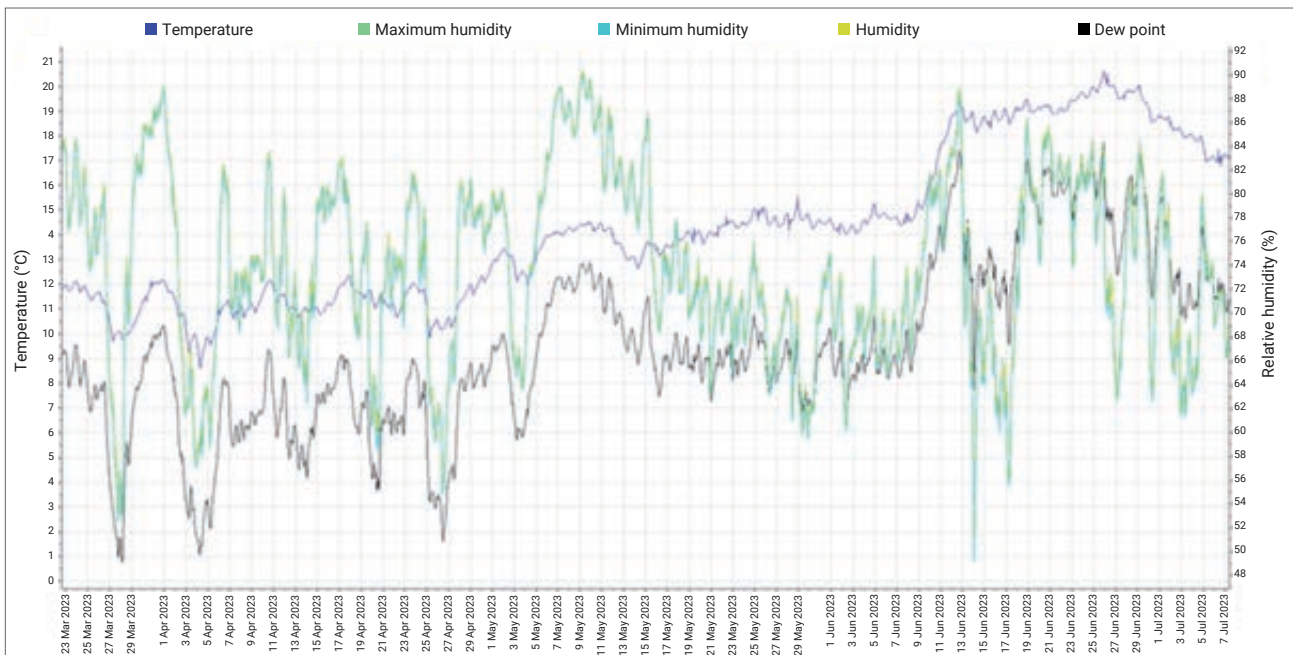
Figure CS4.9 Relative humidity in wall cavity (from 23 March to 21 June 2023)

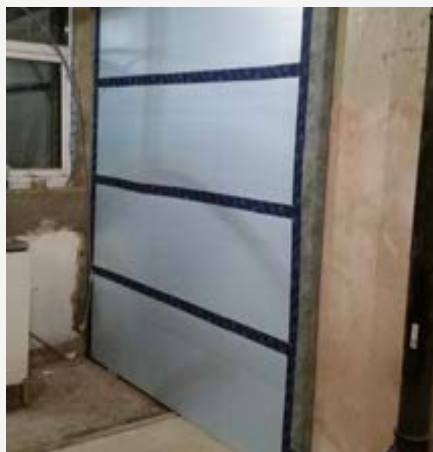
Figure CS5.3 Internal wall insulation on party wall exposed to the outside

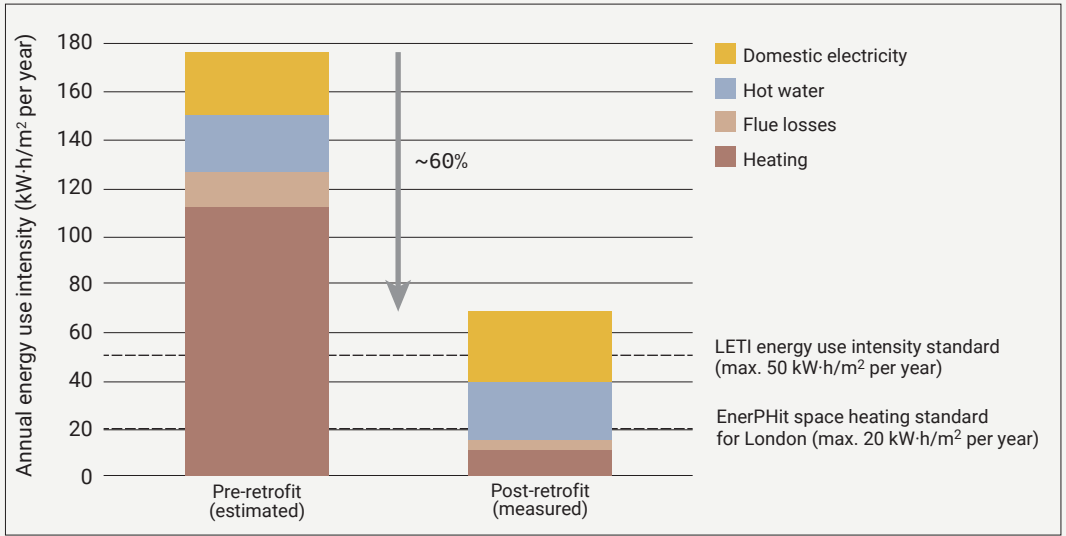
Figure CS5.6 Hensford Gardens; overall EUI comparison before and after retro-fit

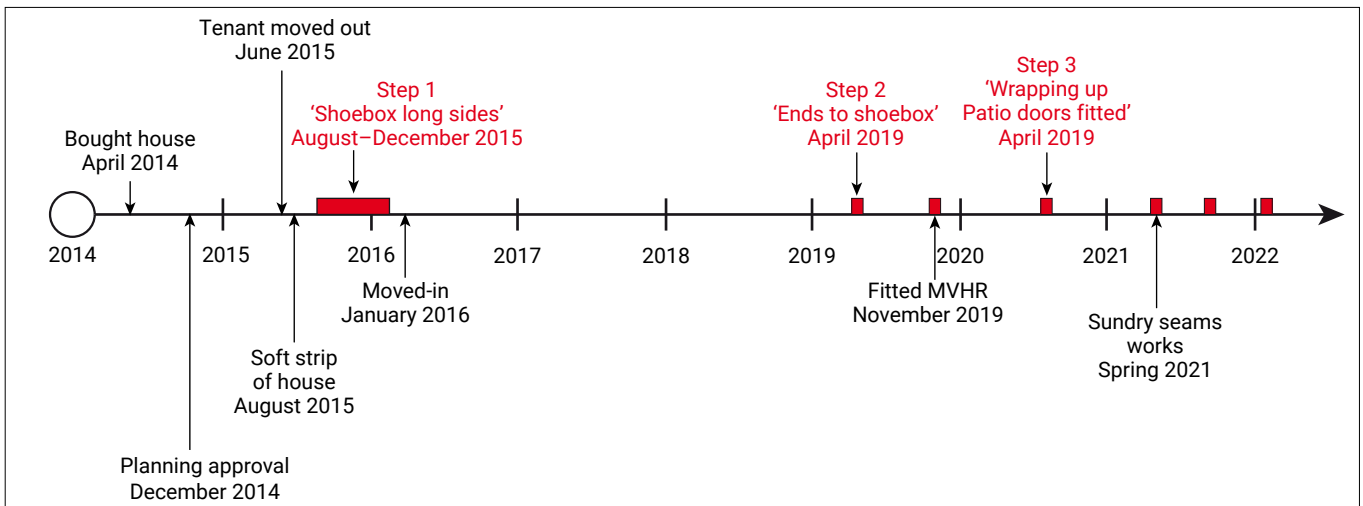
Figure CS5.9 Timeline showing when key retrofit steps were taken.

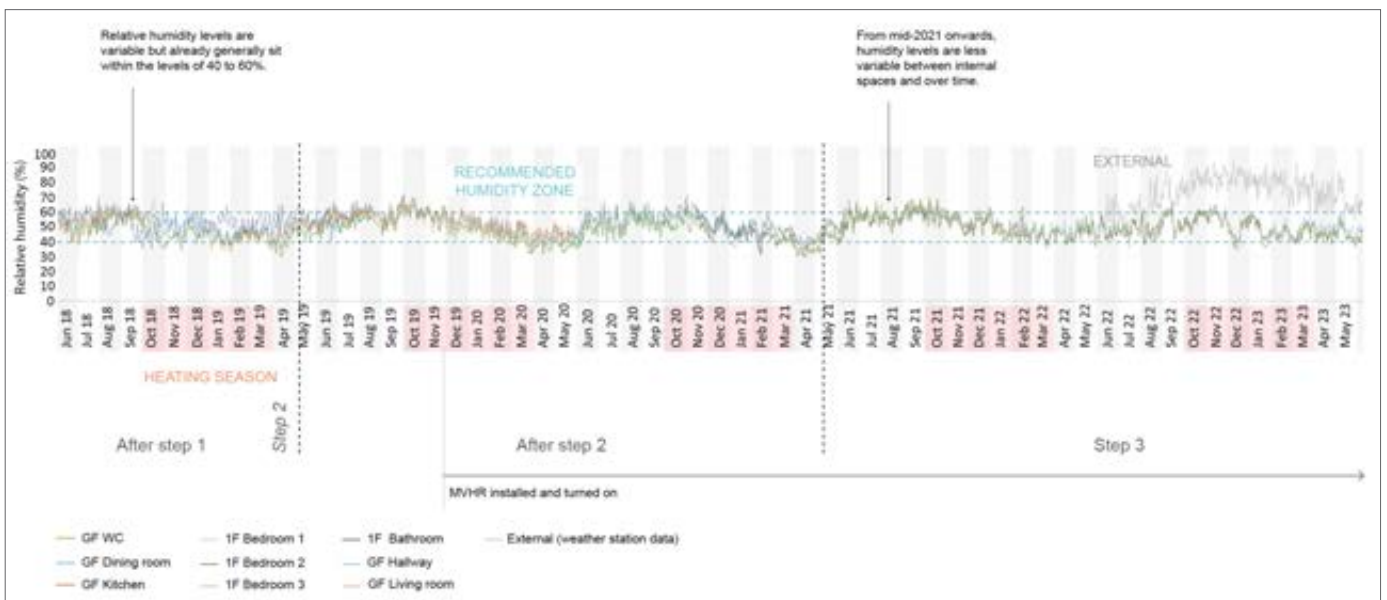
Figure CS5.14 Relative humidity, June 2018–present

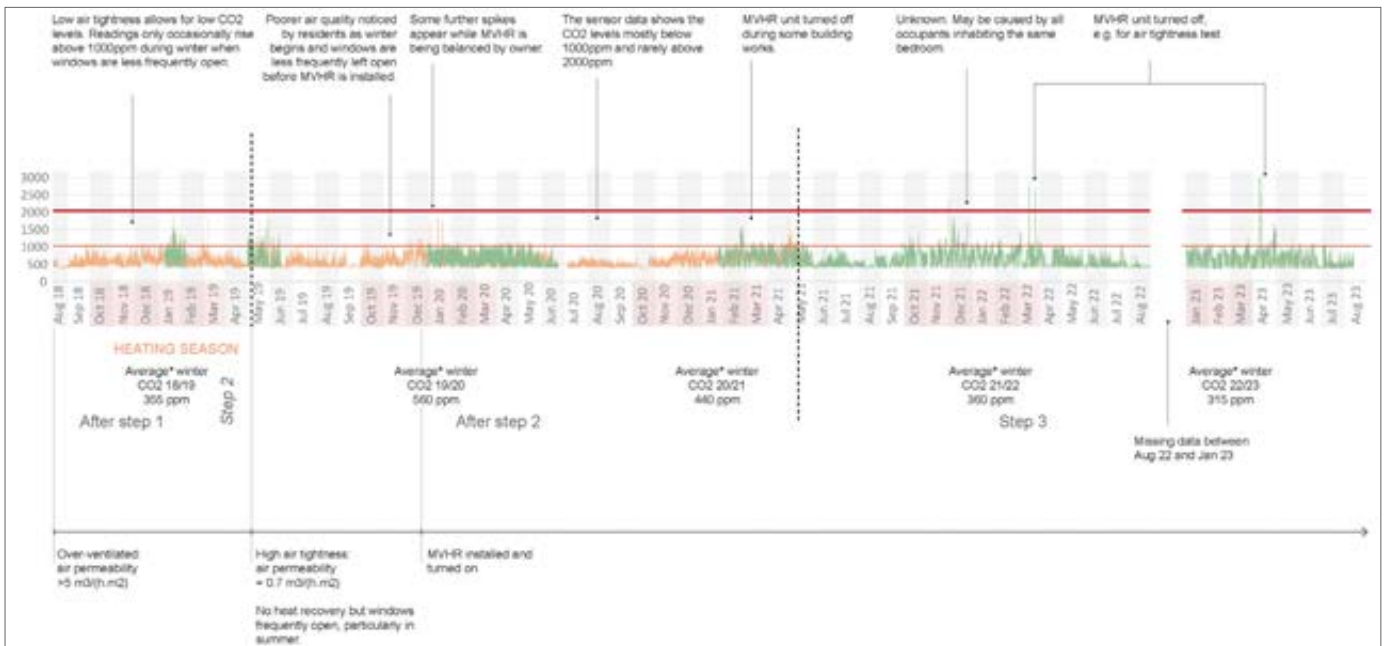
Figure CS5.15 CO₂ sensor data (ppm, hourly average)

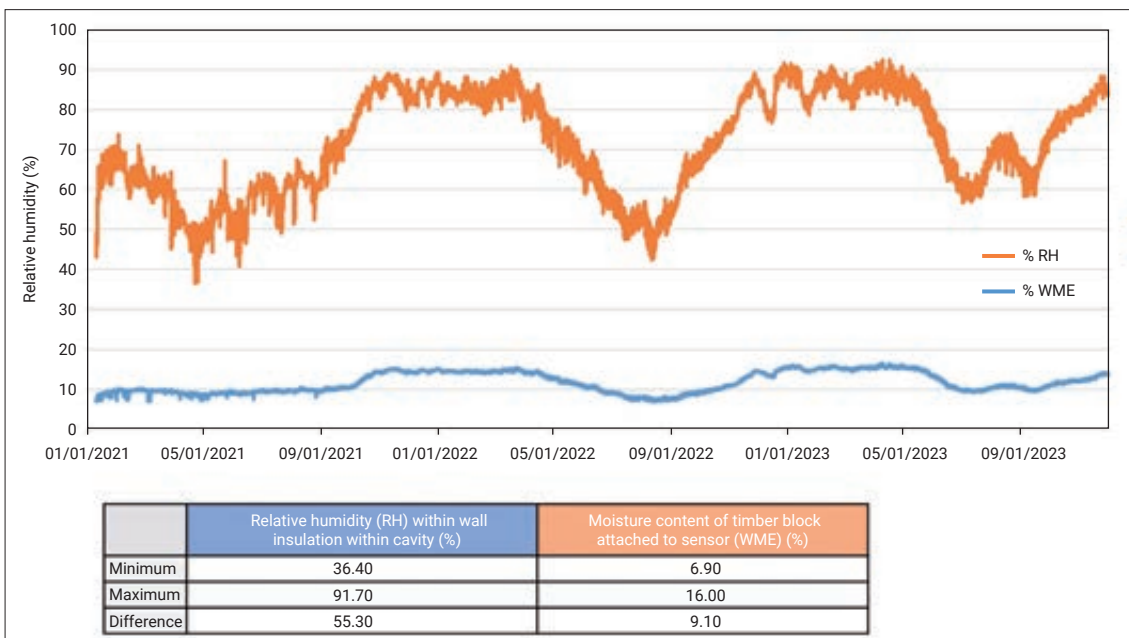
Figure CS5.16 Moisture content within timber block in the middle of one of the cavity walls (from 1.01.2021 to 9.01.2023)

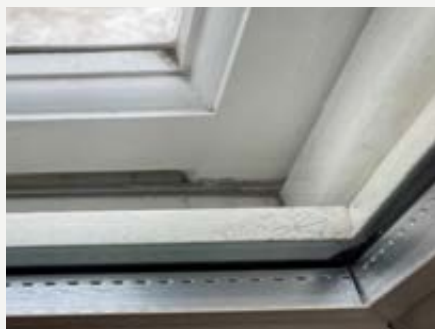
Figure CS6.1 Condensation.

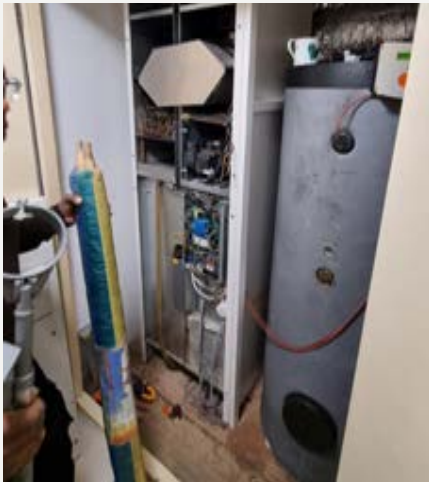
Figure CS7.4 Utility cupboard with MVHR hot water and mini air source heat pump next to complimentary hot water cylinder

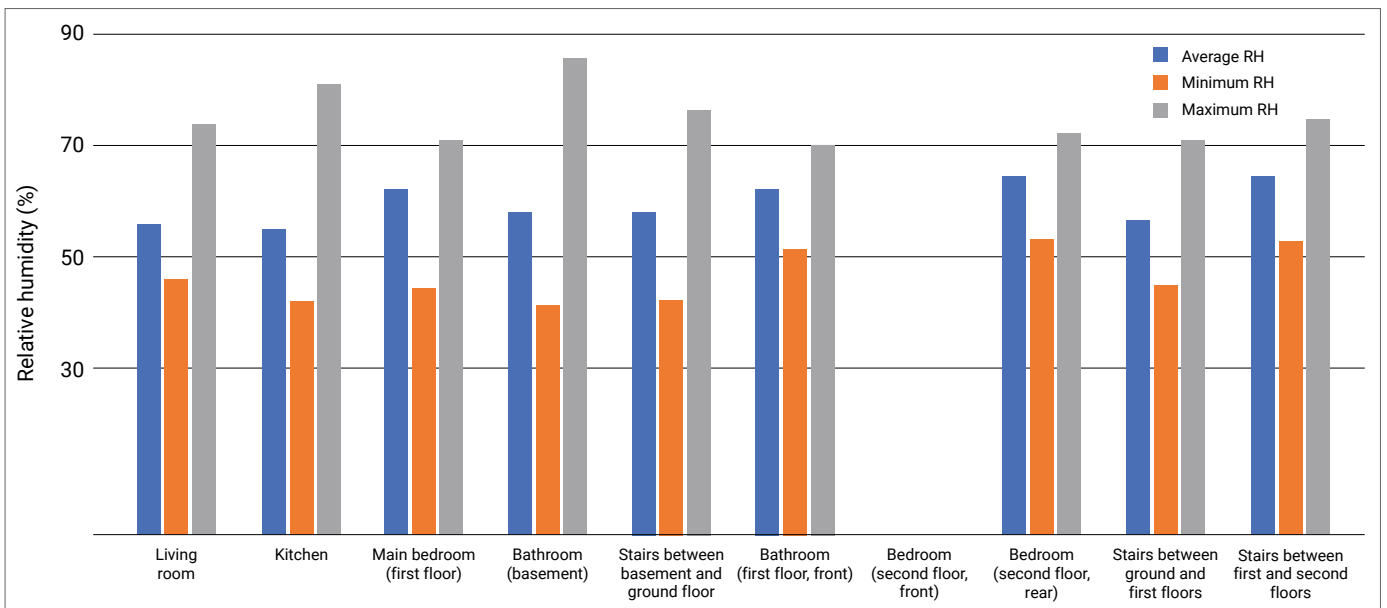
Figure CS7.11 Average, minimum and maximum relative humidity by room (%)

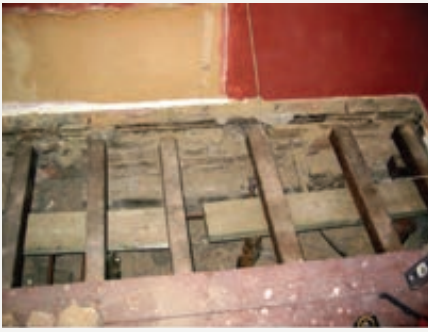
Figure CS8.1 Floor void

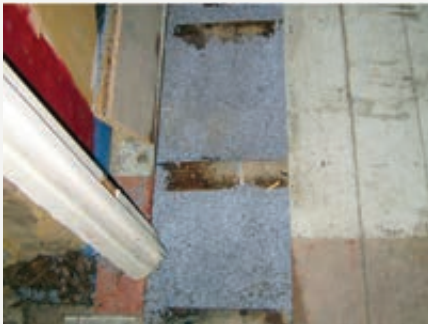
Figure CS8.3 Void filled with insulating beads

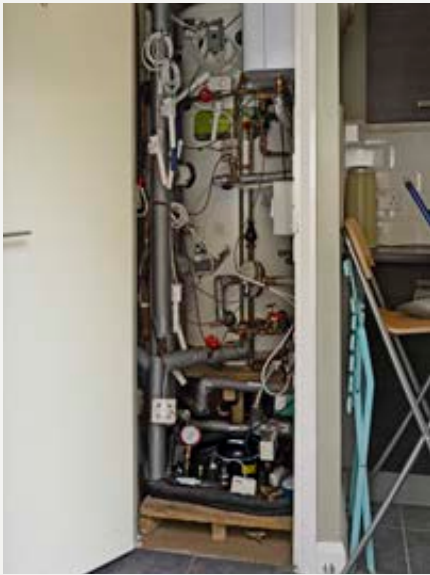
Figure CS8.4 Utility cupboard with conflicting MEP installation

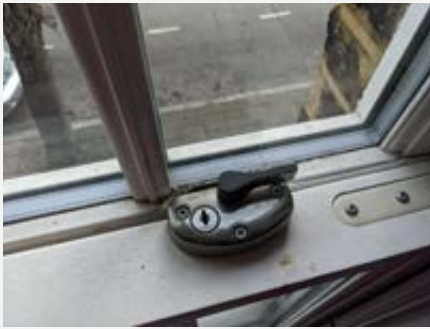
Figure CS8.5 Sash window seal missing to the left of the window catch, contributing to the increased permeability.

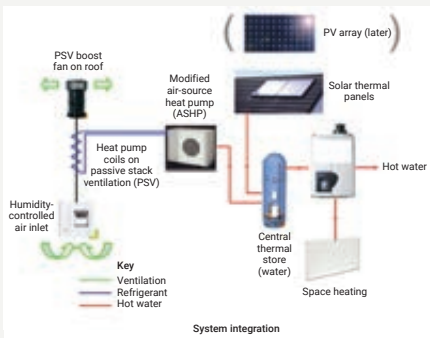
Figure CS8.6 Schematic of the MEP system

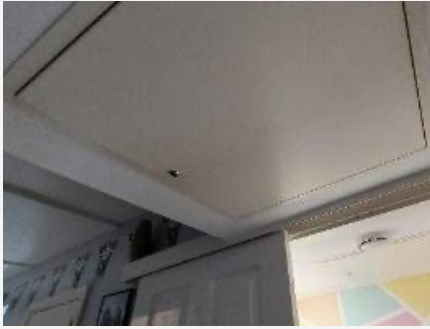
Figure CS9.4 Access panels to MVHR duct distribution in the hall and WC

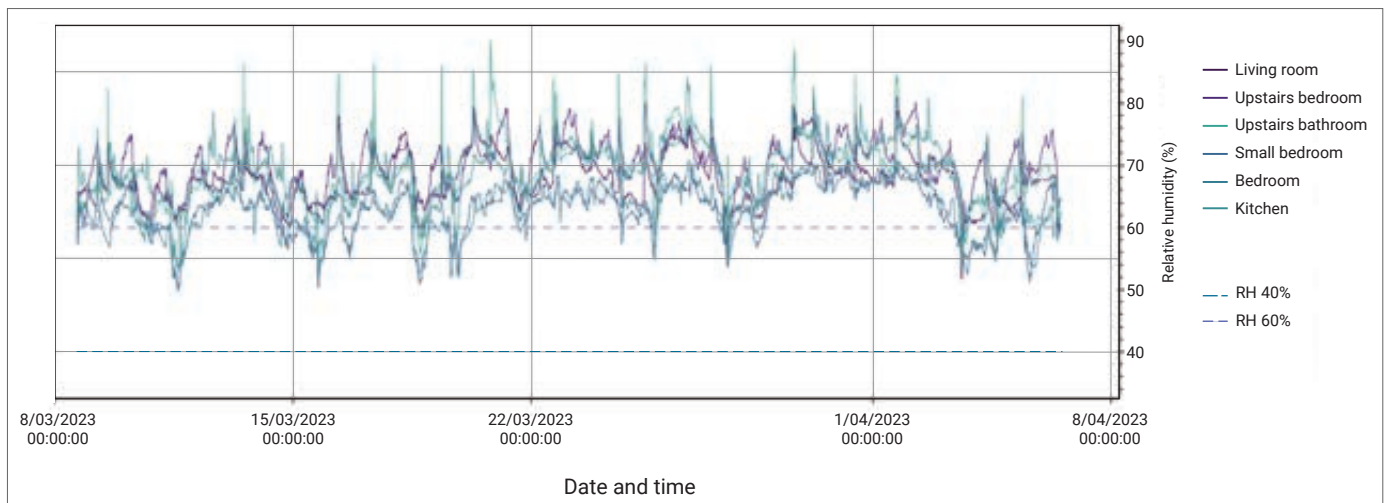
Figure CS9.8 Wilmcote House; relative humidity (%)

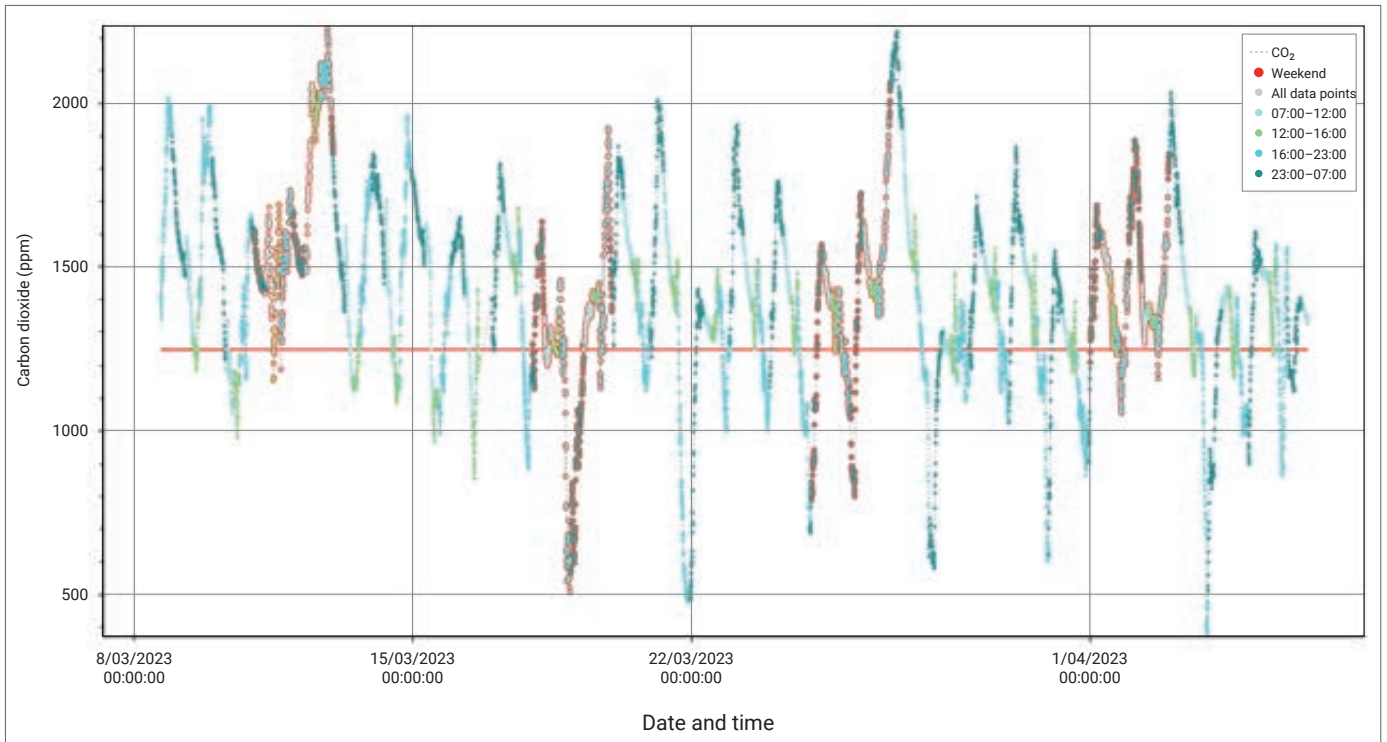
Figure CS9.9 Wilmcote House; carbon dioxide (ppm)

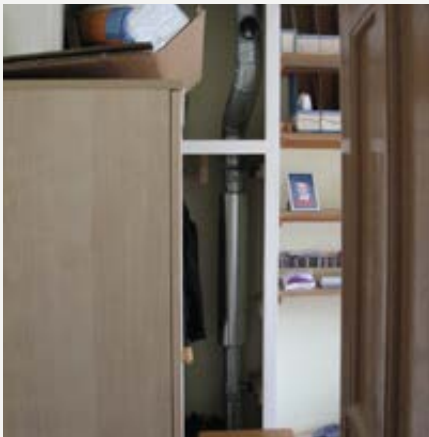
Figure CS10.2 Ventilation duct concealed in wardrobes

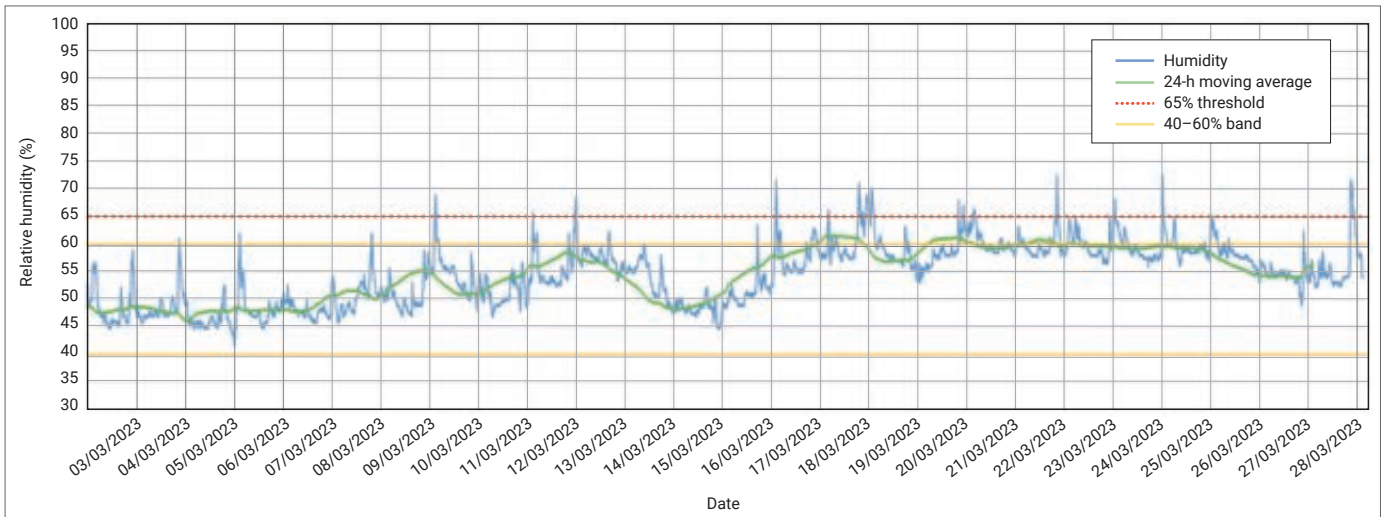
Figure CS10.6 Passfield Drive; Room 1 (GF lounge) humidity (%), March

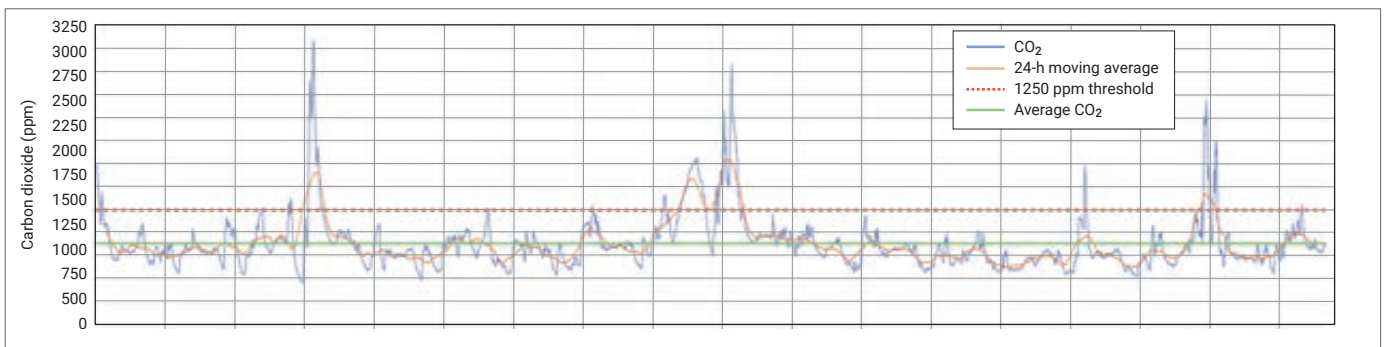
Figure CS10.7 Passfield Drive; Room 1 (GF lounge) carbon dioxide (ppm), March

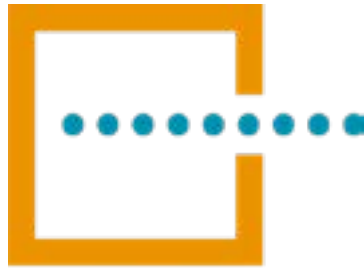
UKCMB
UK CENTRE FOR
MOISTURE
IN BUILDINGS

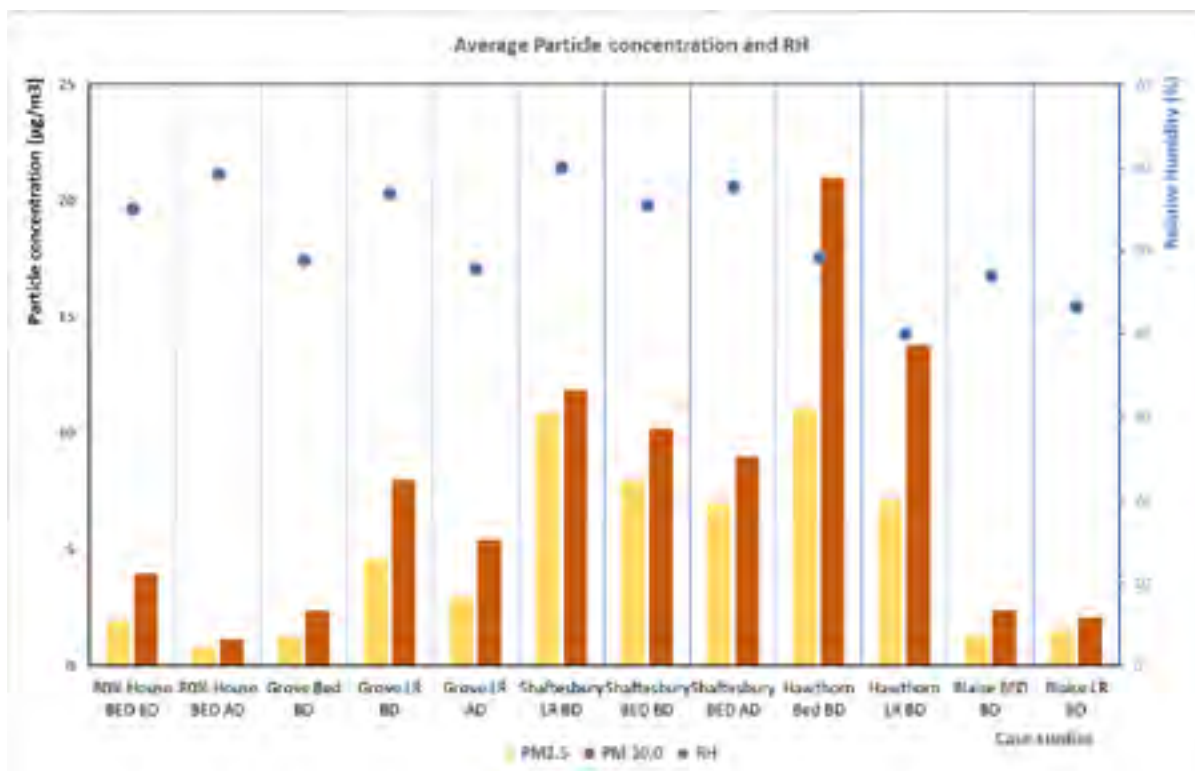
Figure 1. Spot measurements of RH and concentration of PM2.5 and PM10

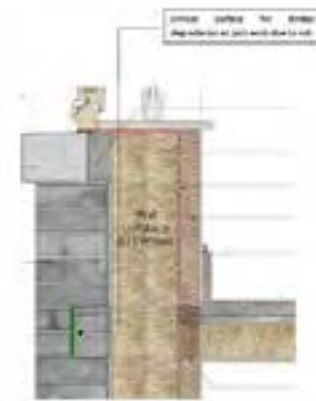
The analysis found the relative humidity at the wall-insulation interface to be persistently higher than 80%, leading to high mould growth risk, apart from the case of Brick 3. This was the brick with the lowest water absorption coefficient of the three bricks tested, $A_w=0.116 \text{ kg}/(\text{m}^2\text{s}^{0.5})$, similar to the values measured in the property by means of Karsten tube testing.

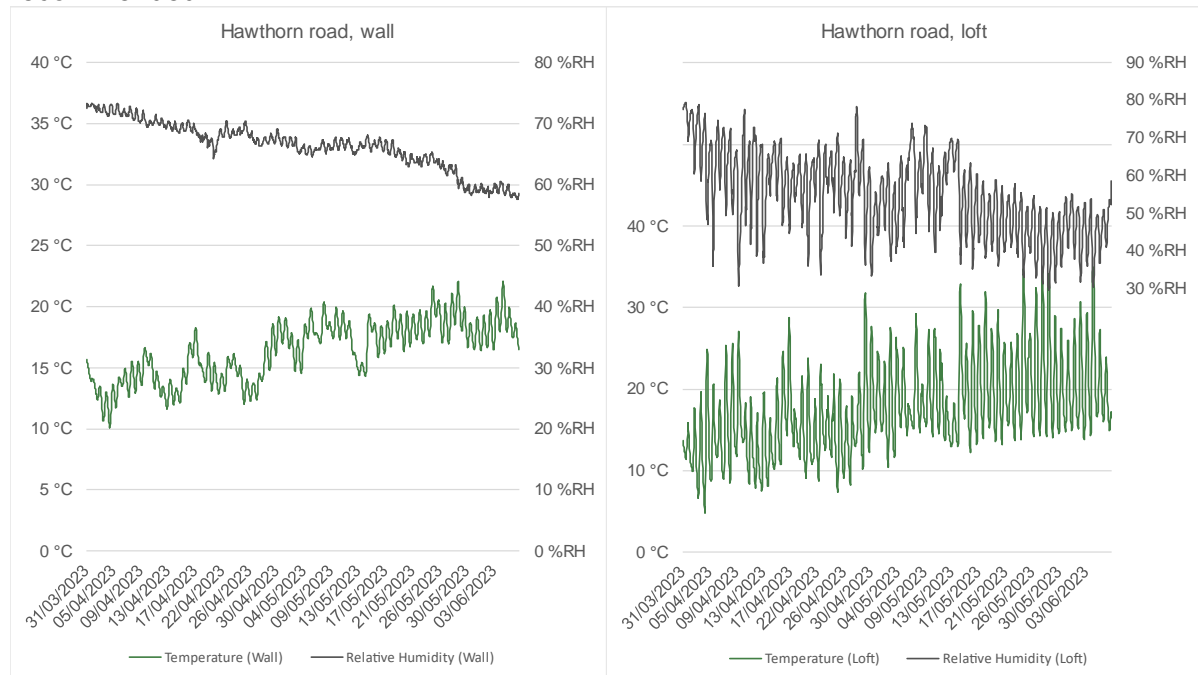
Figure 3 Temperature and relative humidity of internally insulated wall (left) and loft (right) in Hawthorn road

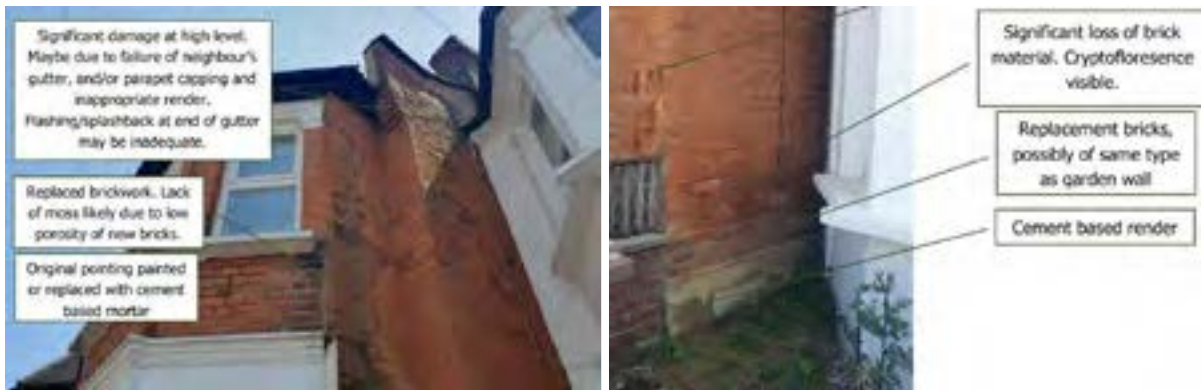
Figure 4 Damage near the gutters (left) and above the ground floor (right) on the west wall

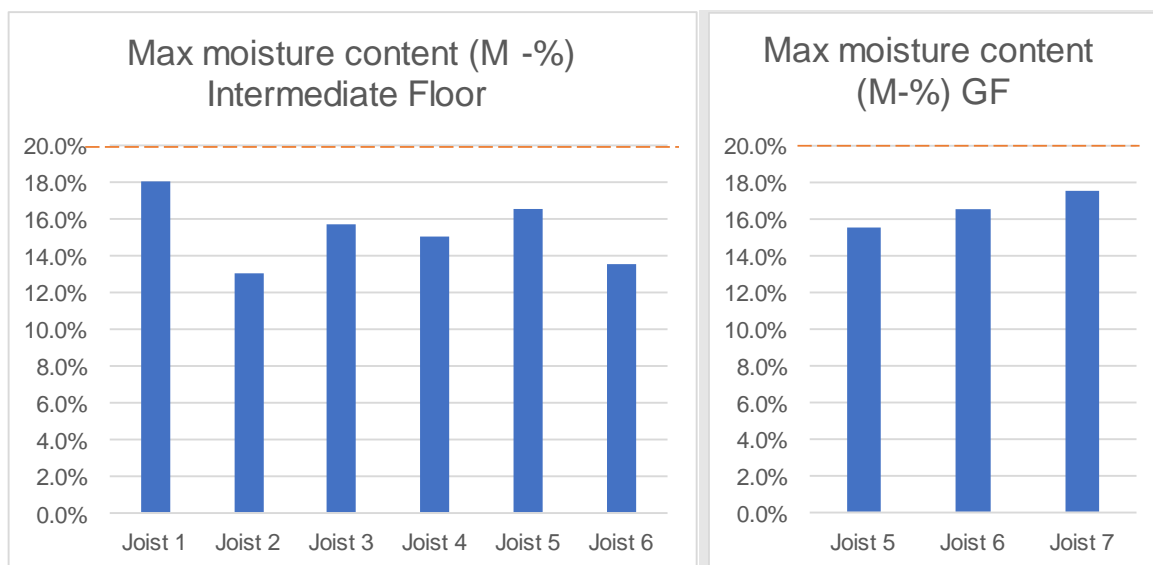
Figure 5 Maximum moisture content of the joists in the intermediate floor (left) and ground floor (right) and 20% threshold. The joists were counted from left to right.

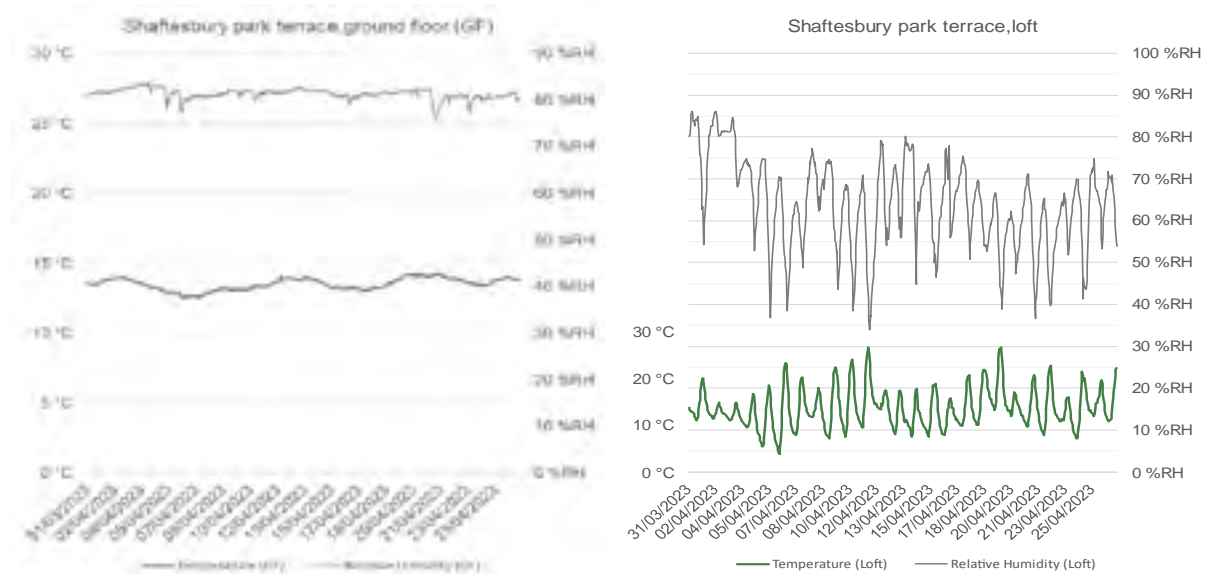
Figure 6 Temperature and relative humidity of suspended ground floor (left) and loft (right) in Shaftesbury park

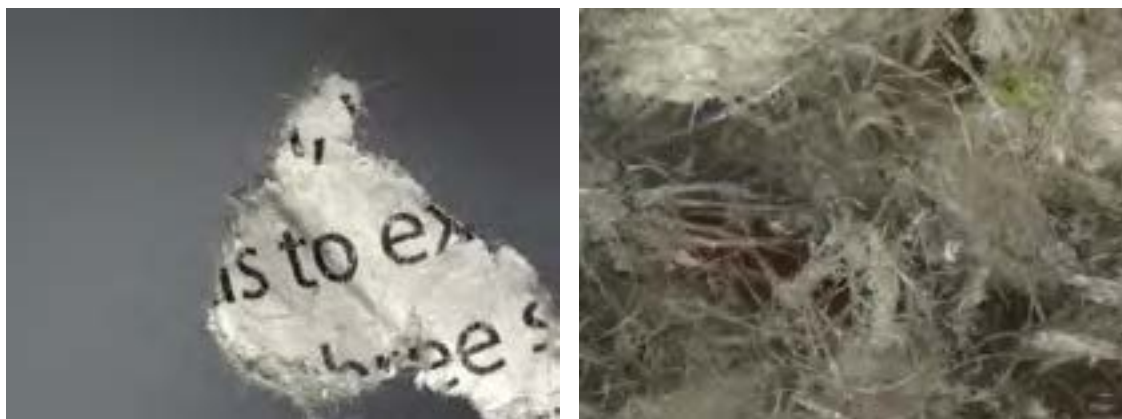
Figure 7 Inspection of loft insulation under an optical microscope; the inspection found no mould growth in the analysed sample.

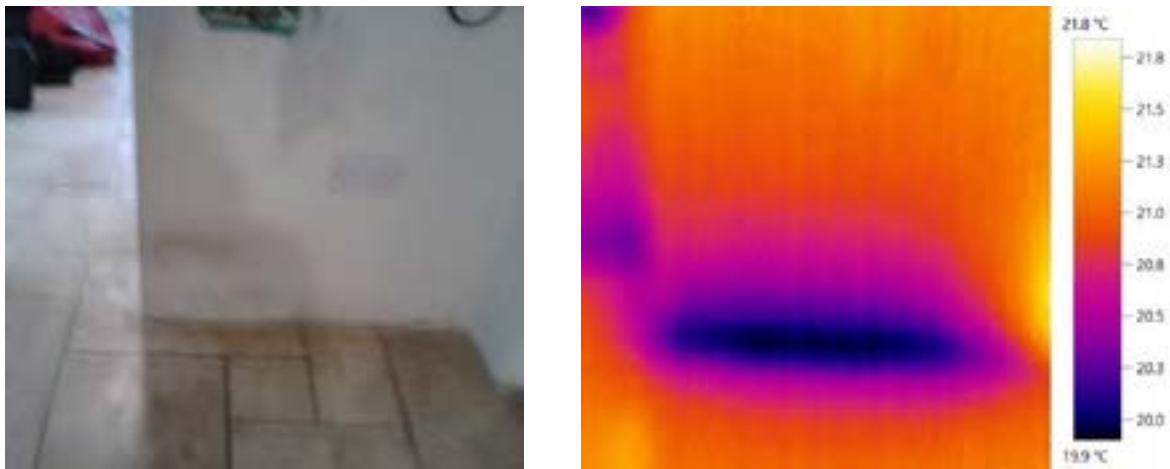
Figure 8 Photo (left) and Infrared image (right) of visible dampness in the hallway of Grove cottage

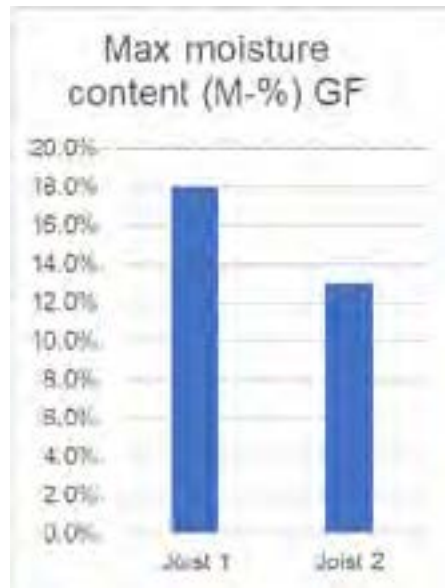
Figure 9 Maximum moisture content of the joists in the ground floor (right) and 20% threshold. The joists were measured from left to right.

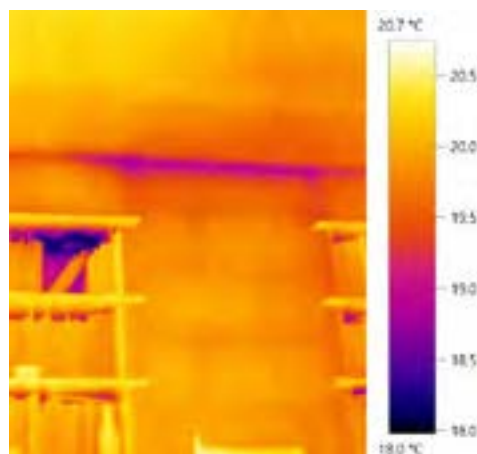
Figure 10: Infrared image of visible dampness in the living room of the 80% house.

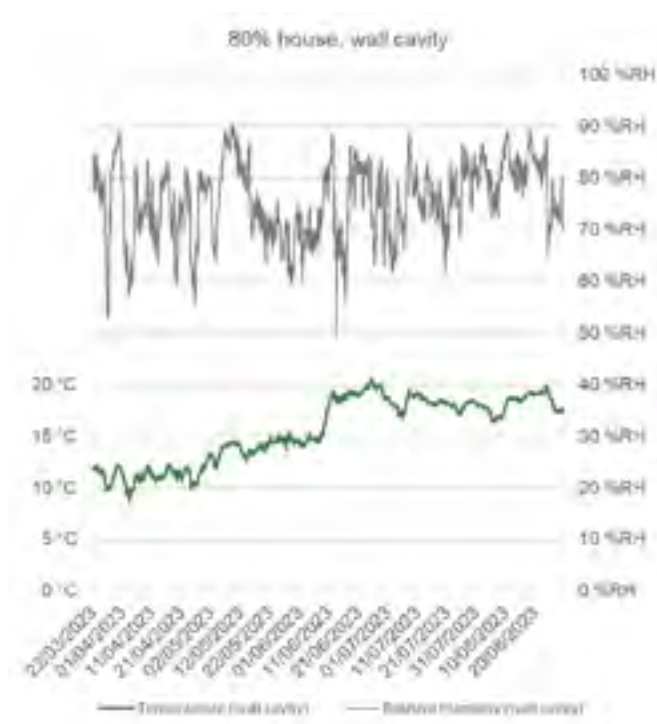
Figure 12: Temperature and relative humidity of wall cavity in the 80% house

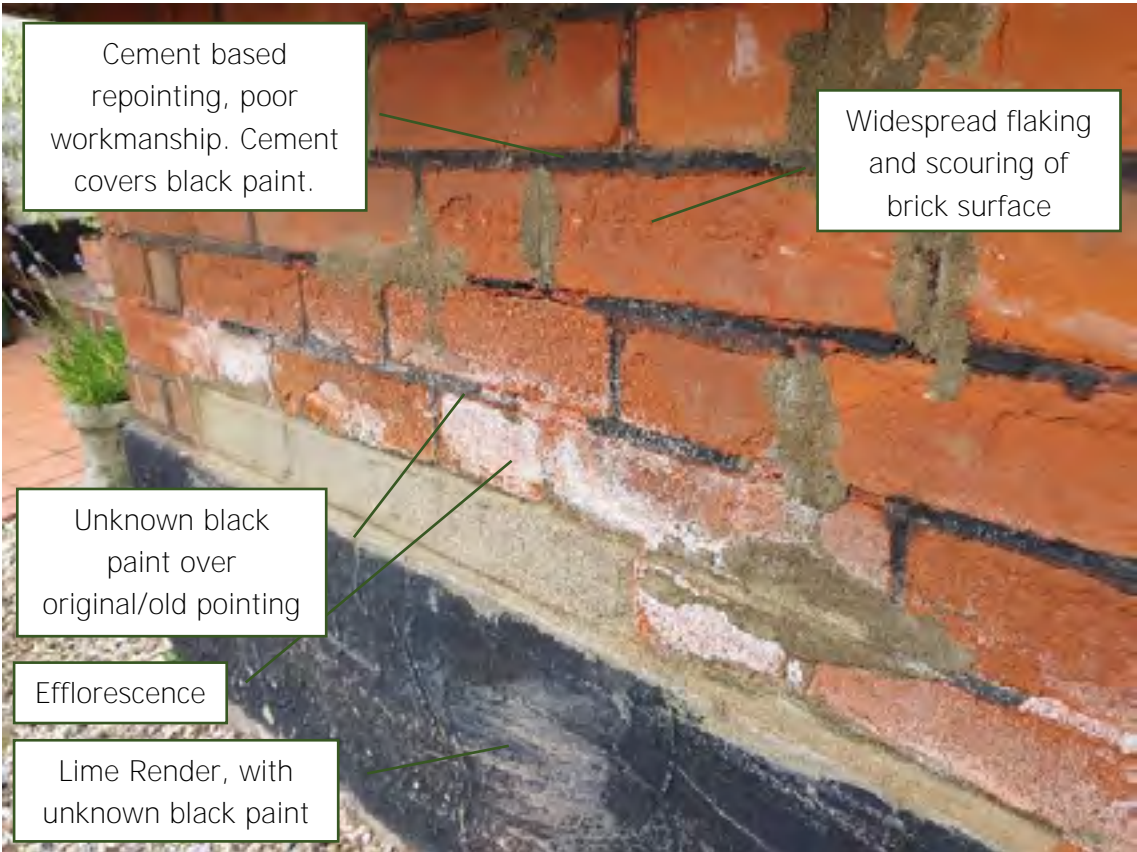
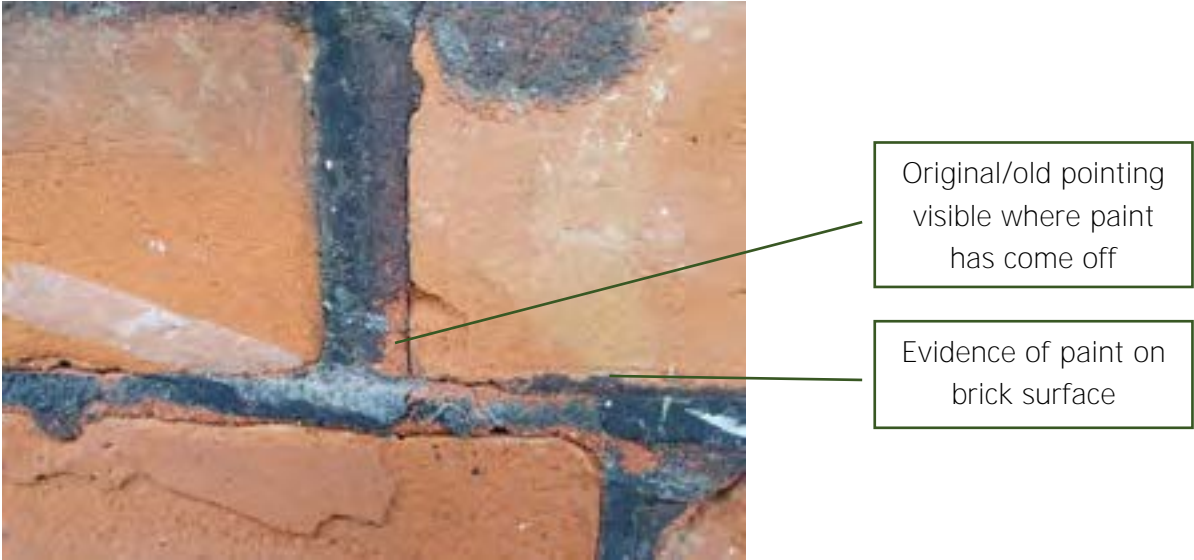
The IWI alone could in theory increase freeze-thaw risk however the simulations below indicate that there are more significant factors in this particular case. The IWI has an influence on drying and crystallisation behaviour associated with the rising damp, but again, other factors are likely to be more important.

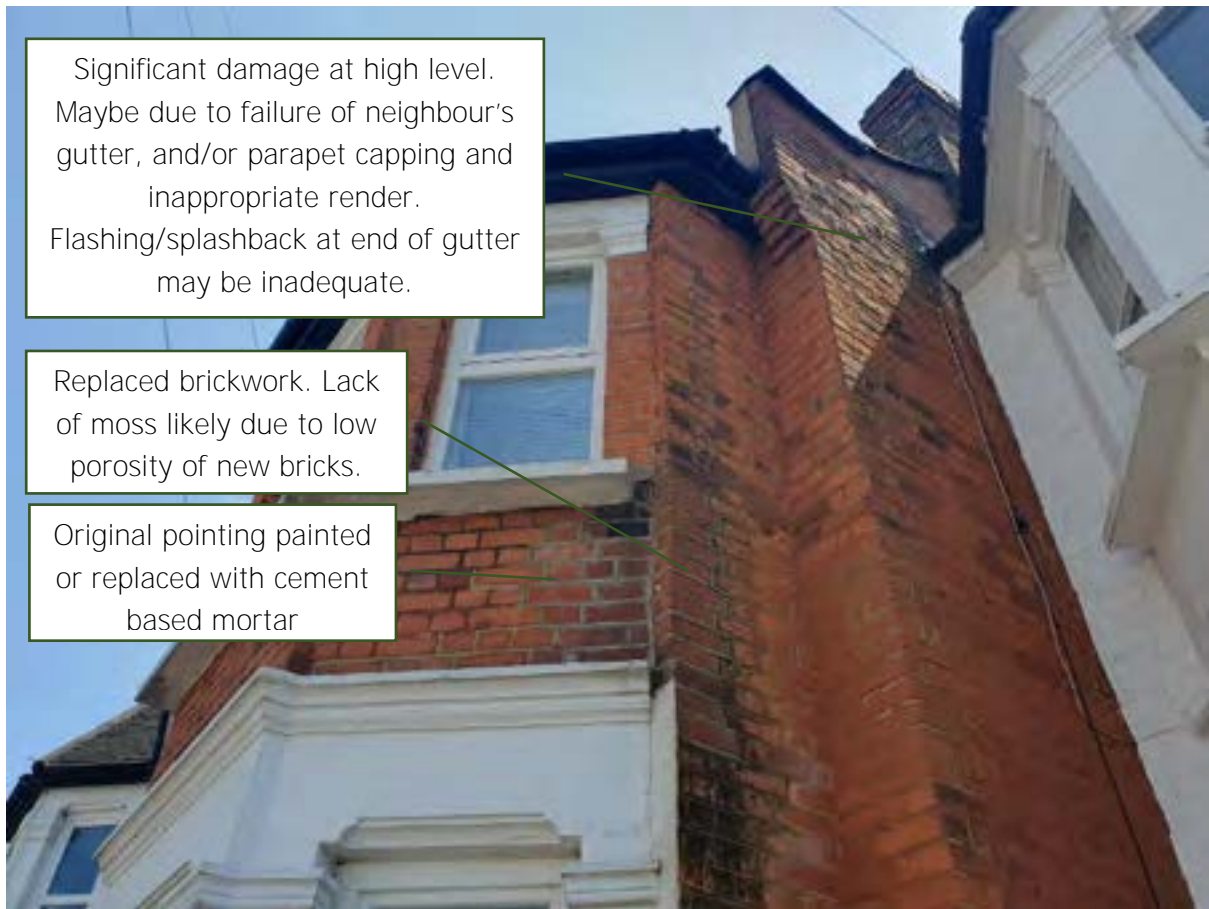
Significant damage at high level. Maybe due to failure of neighbour's gutter, and/or parapet capping and inappropriate render. Flashing/splashback at end of gutter may be inadequate.
