Retrofit Revisit: 10 Case Studies

Julie Godefroy and Marion Baeli

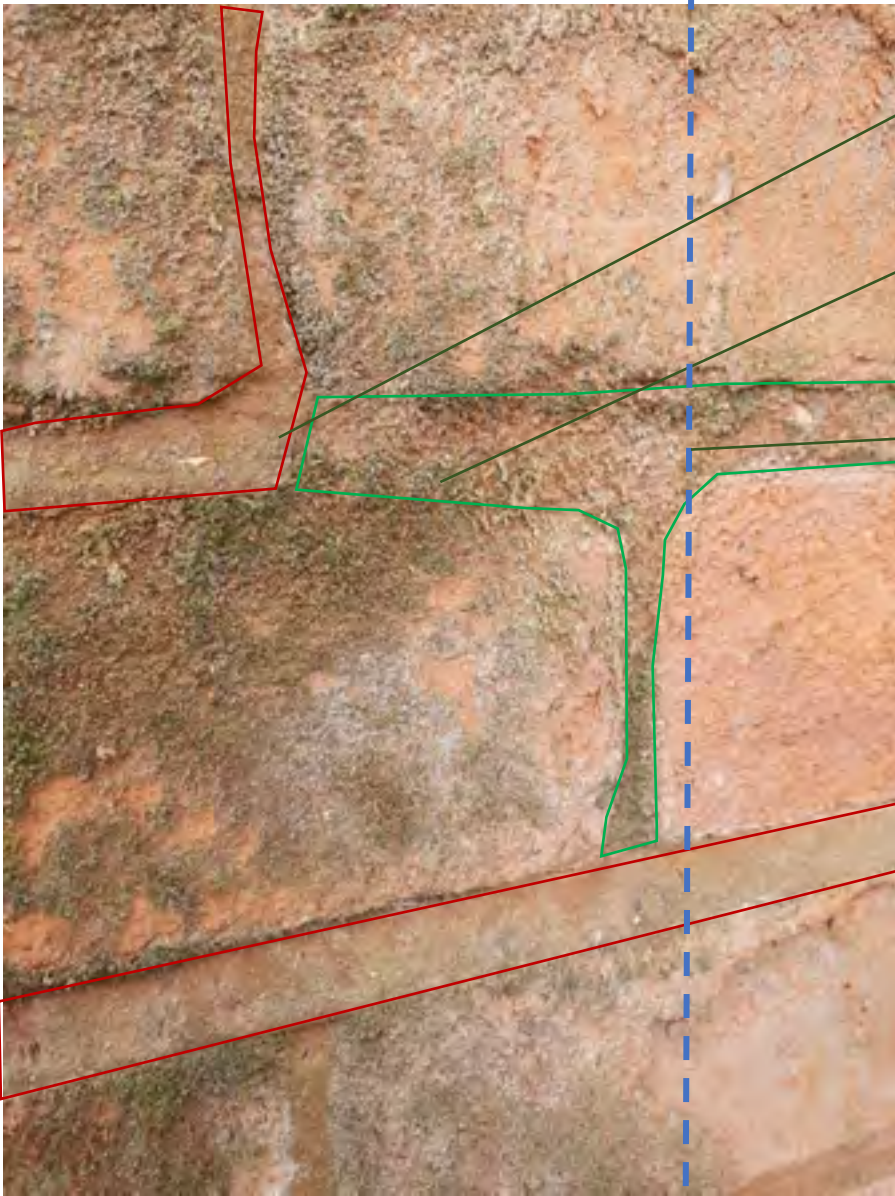
Cement based pointing, no moss growth

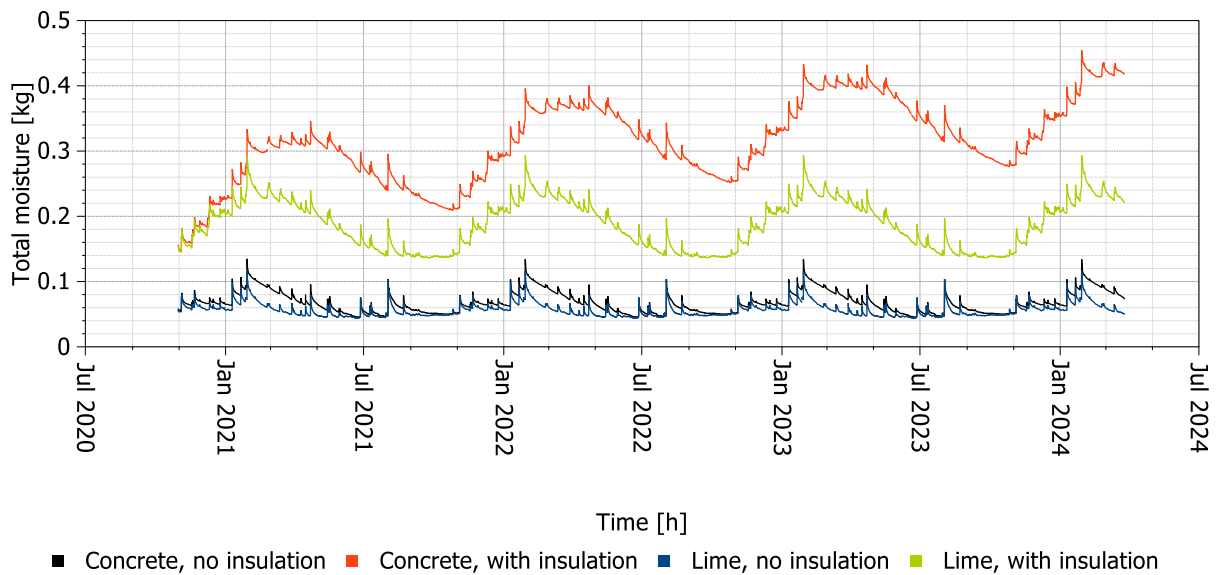
Figure 1: Total WMC, cases A-D

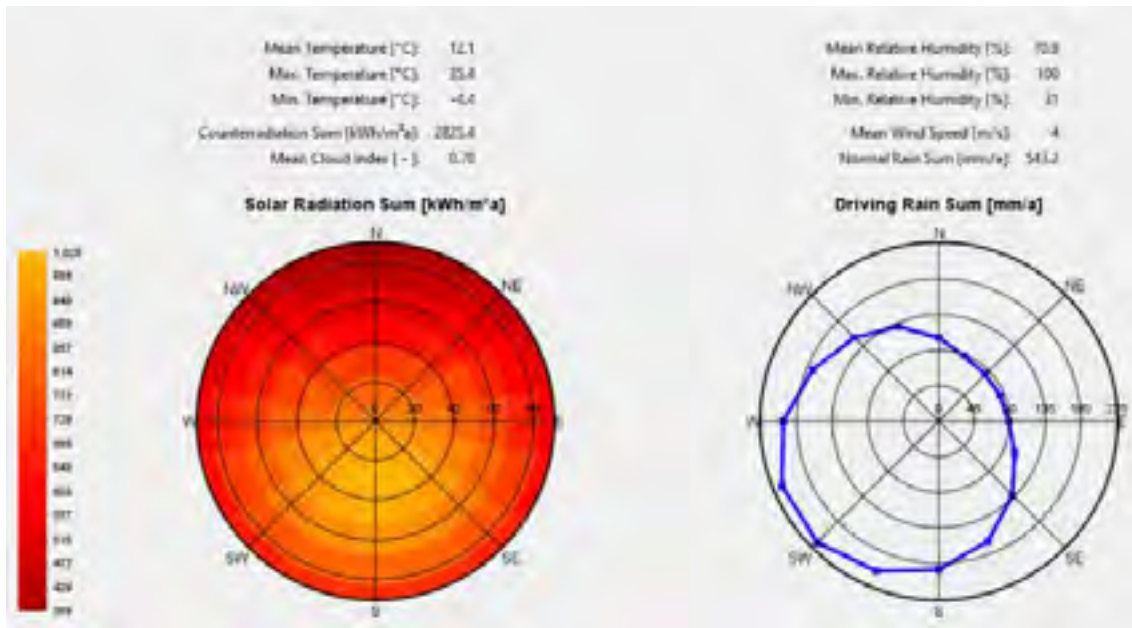
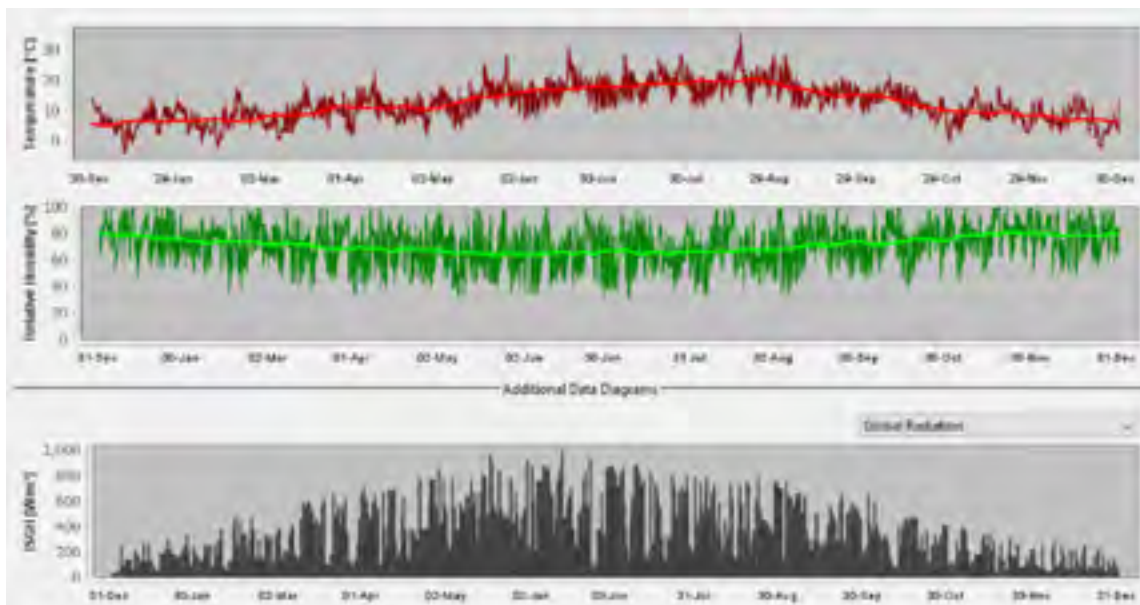
For this simulation, a synthetic weather file for a “Design Reference Year” is created for the project’s location, following the procedure set out in BS 15026. The “Design Reference Year” is constructed to cause the most severe conditions likely to occur once every 10 years. A summary of the weather data included in the synthetic weather file for a “Design Reference Year” is displayed below.

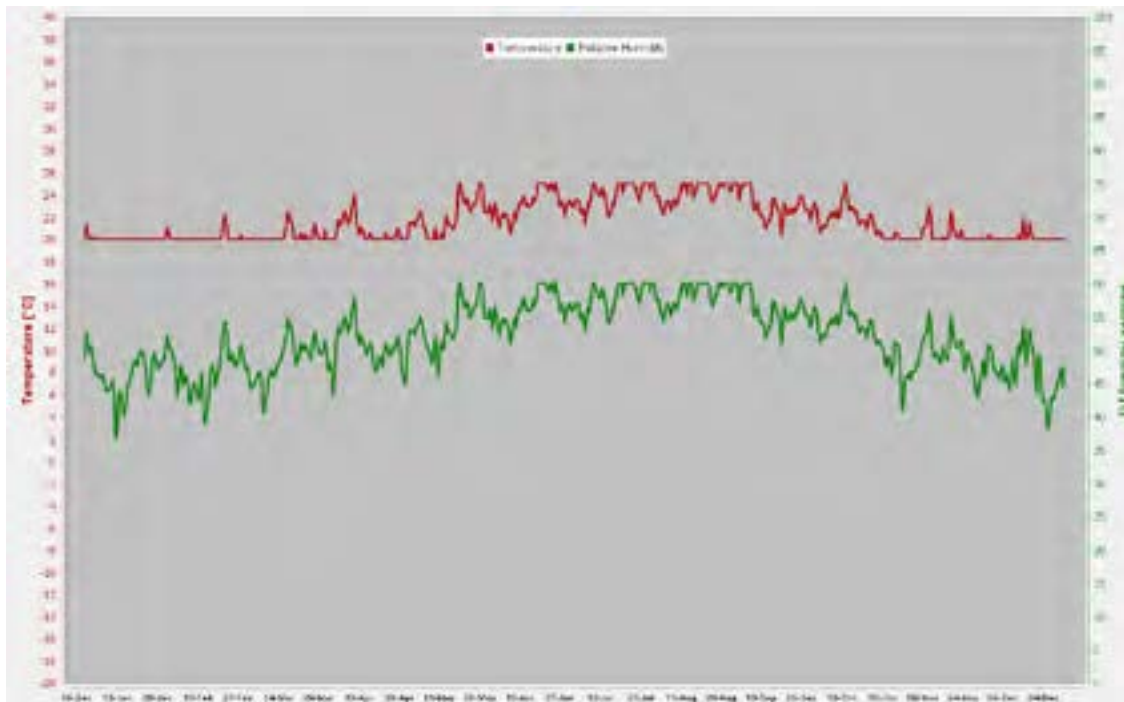
4.5 As-Built In-Situ Conditions

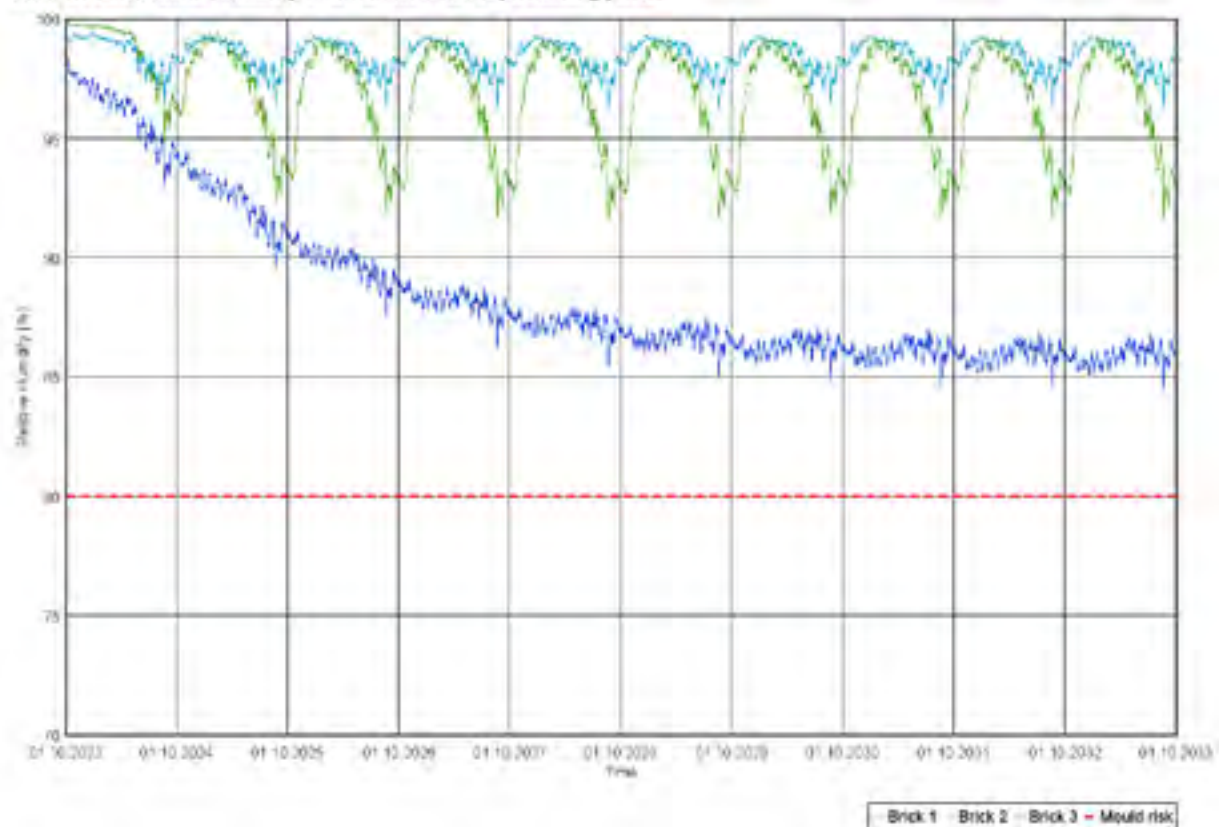
Rear elevation: Relative Humidity at the the inner side of pre-existing plaster

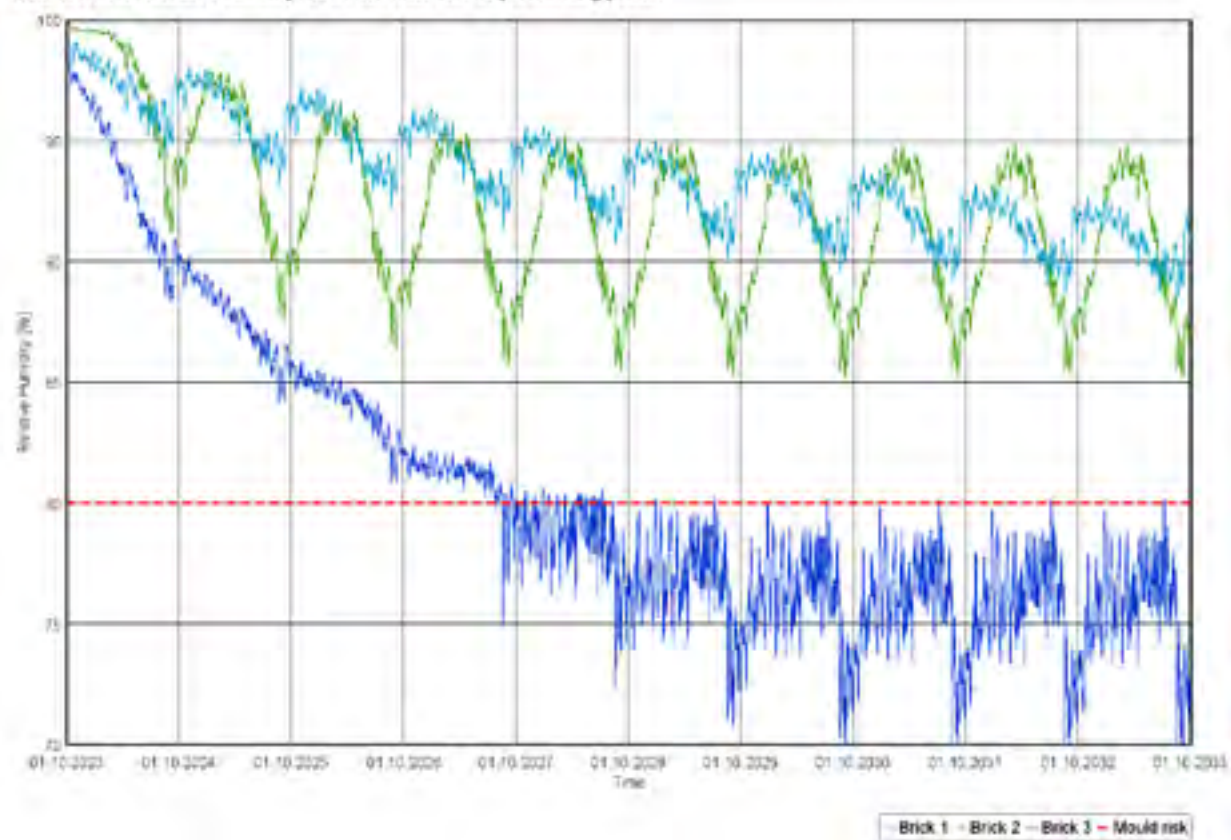
5.2 Assessment against timber rot risk

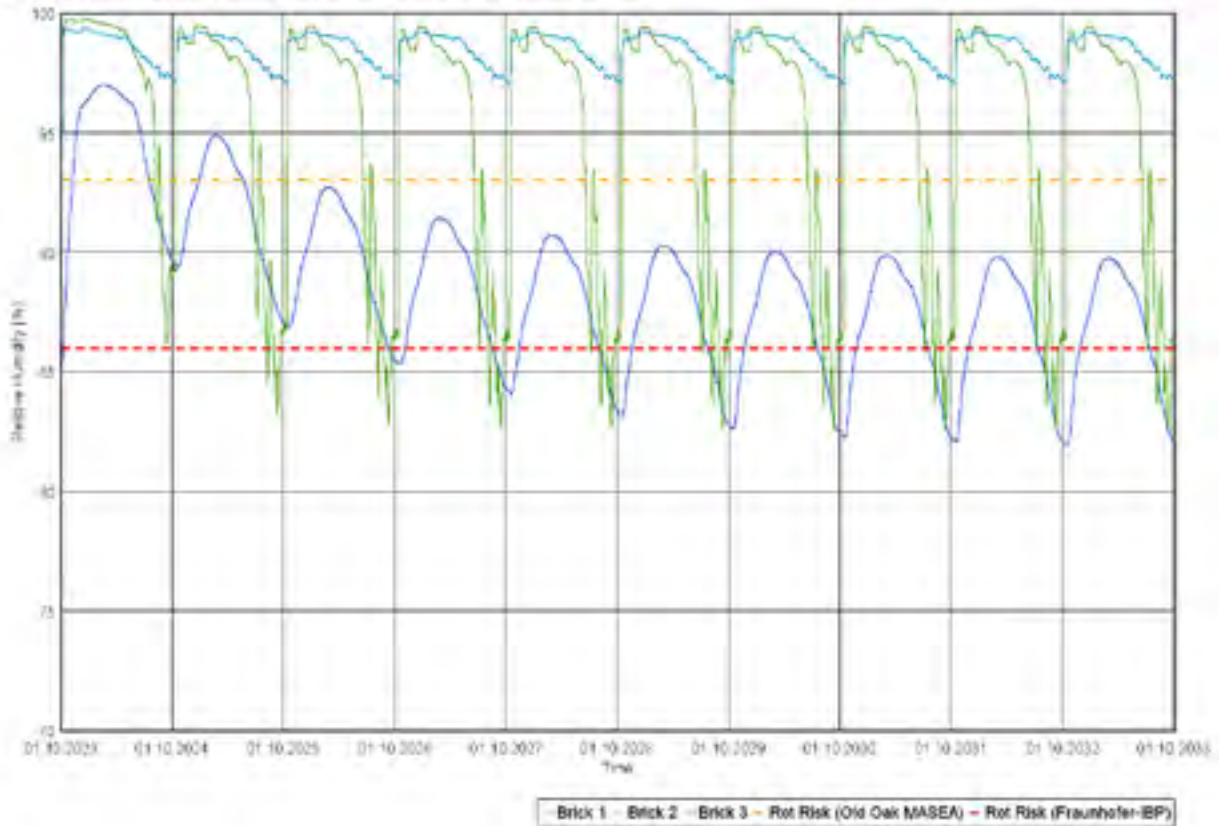
Rear elevation: Relative Humidity at the the position of the timber joist end

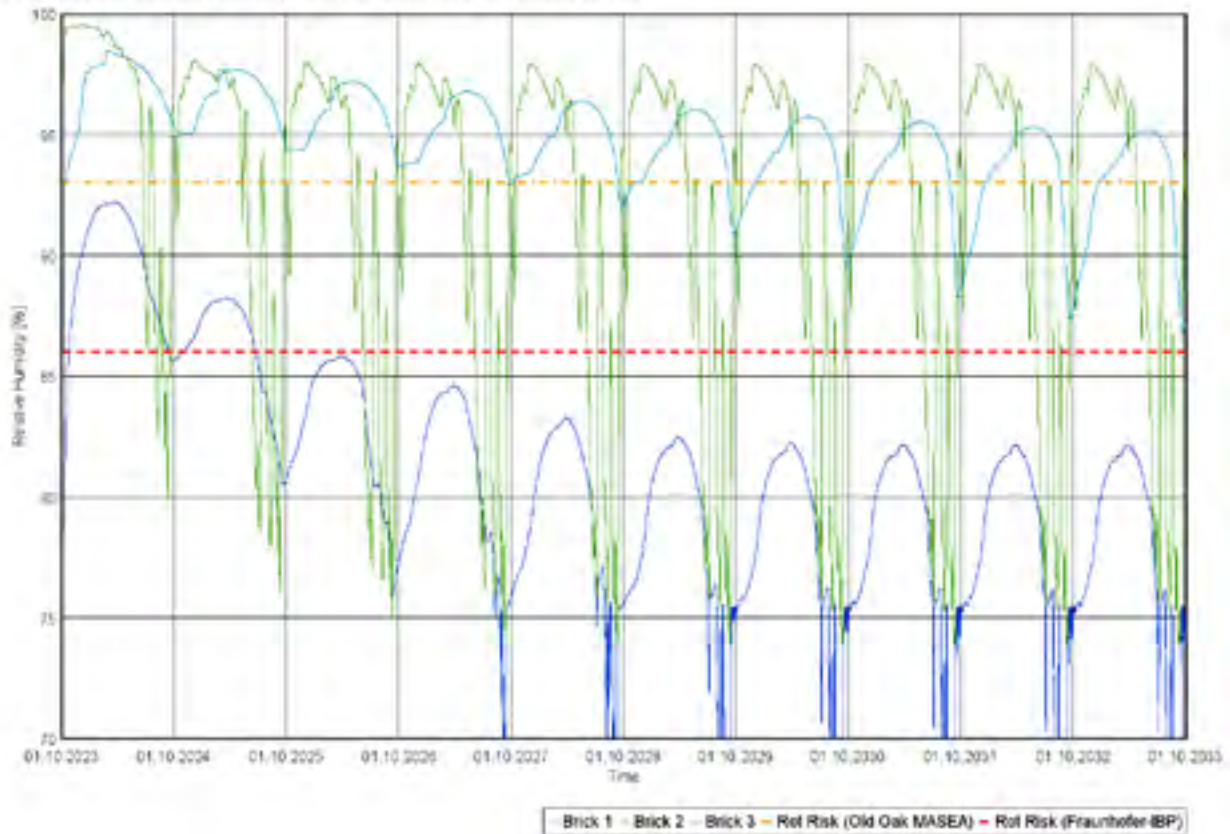
5.3 Assessment against freeze-thaw deterioration

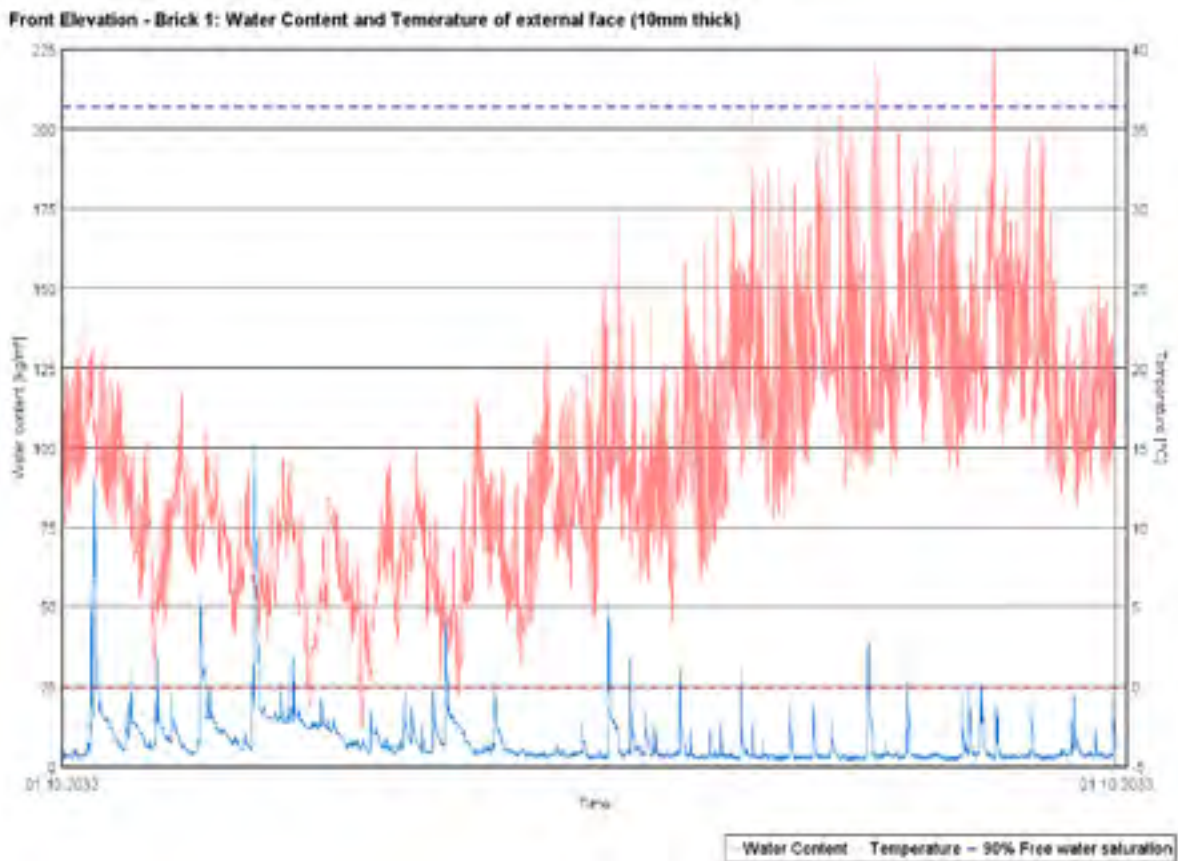
Front Elevation - Brick 2: Water Content and Temperature of external face (10mm thick)

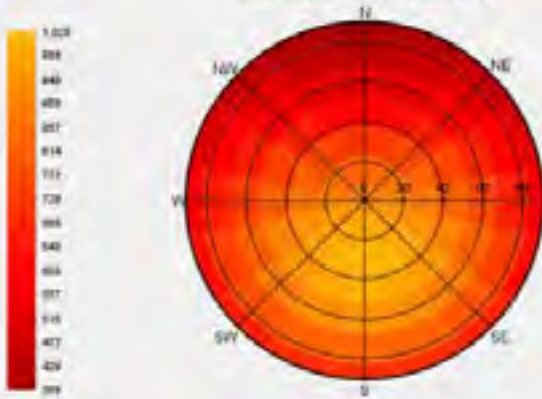
Driving Rain Sum [mm/a]

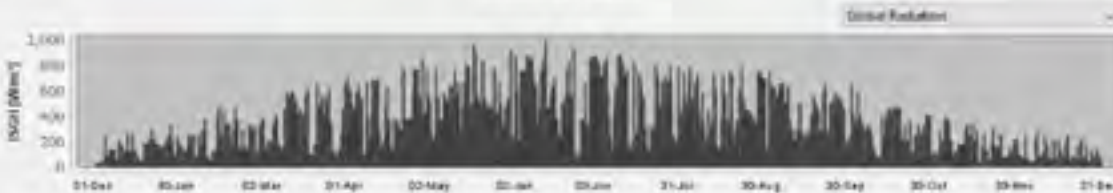
Additional Data Diagrams

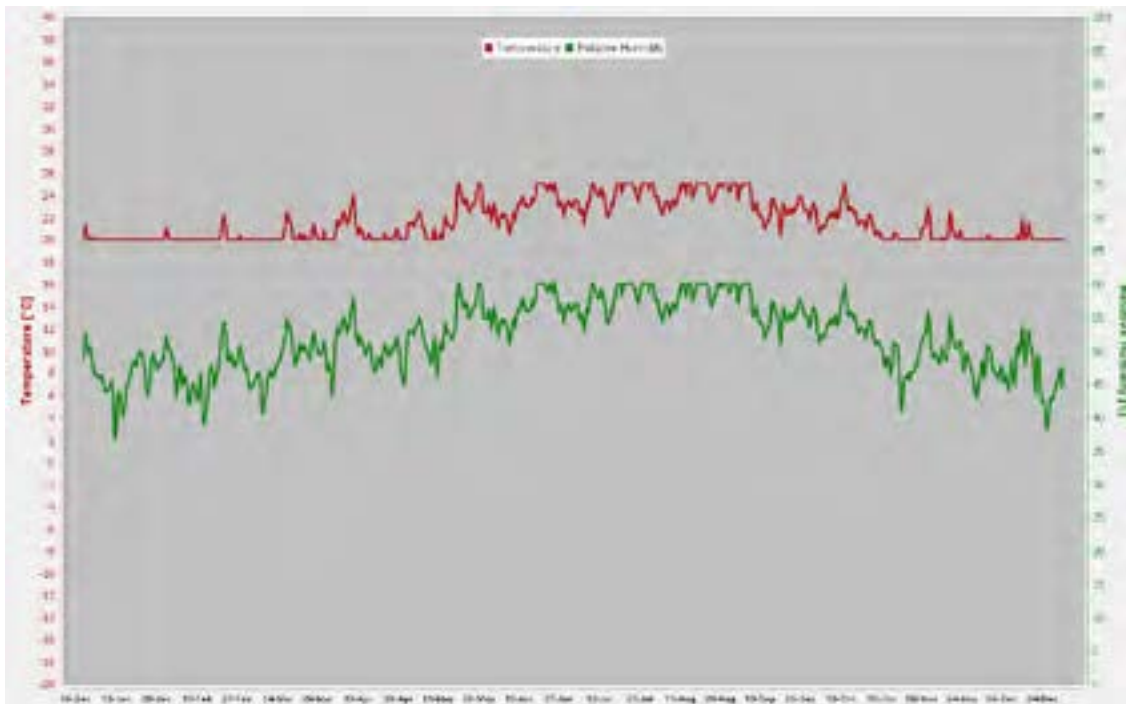
4.5 As-Built In-Situ Conditions

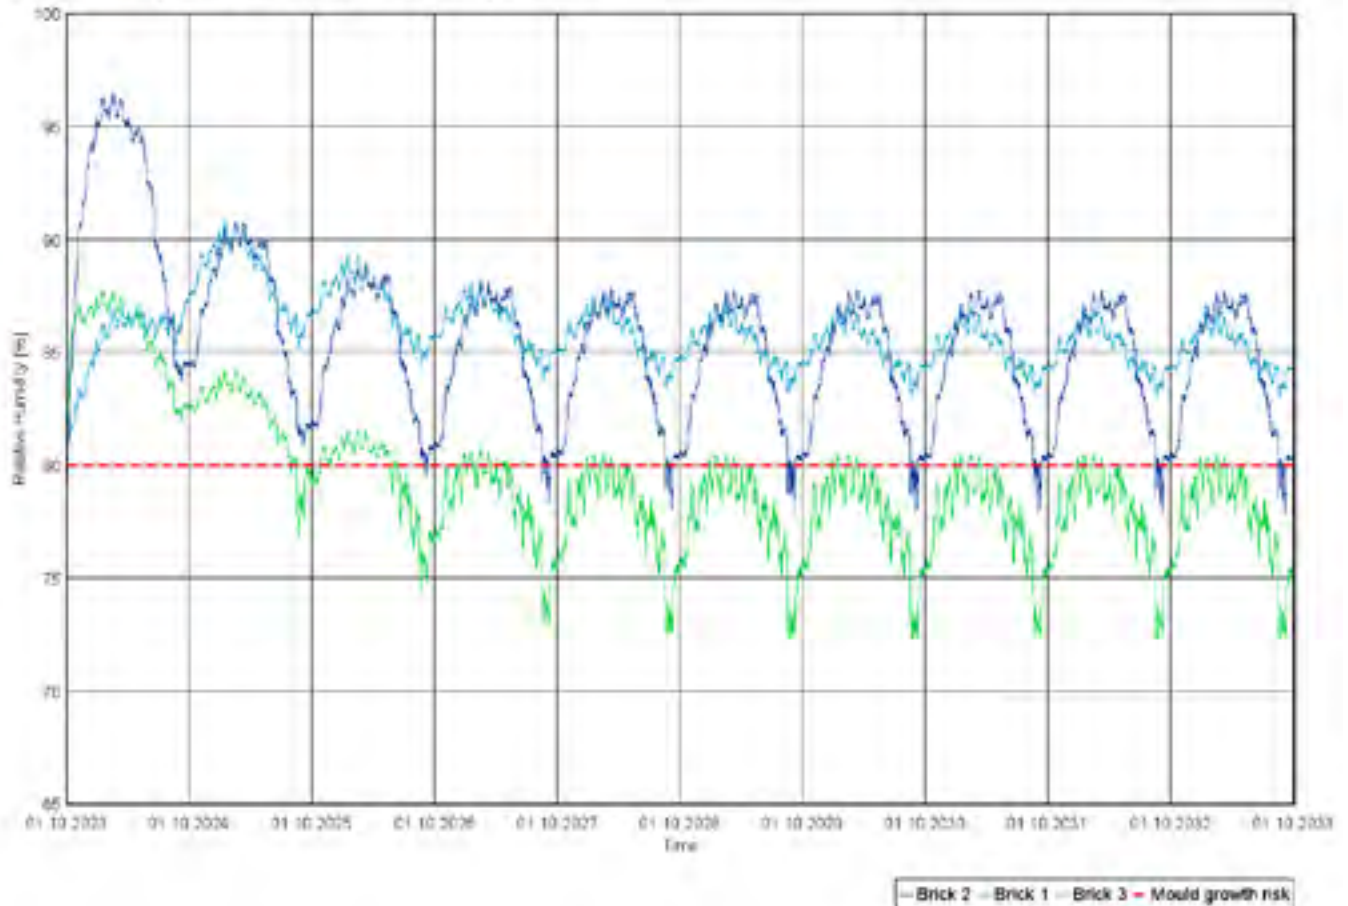
On the other side, in the modelling case related to Brick 3 (least absorbent brick), a decrease in the RH levels is observed until an equilibrium state is reached with fluctuations between approximately 73-80% RH.

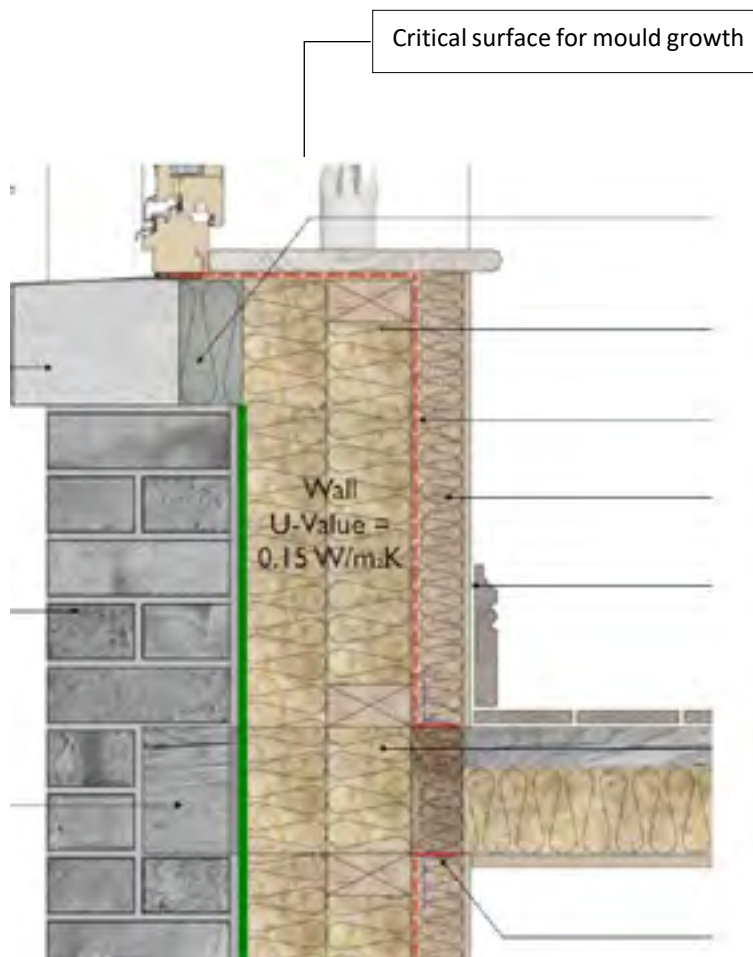
5.2 Assessment against timber rot risk

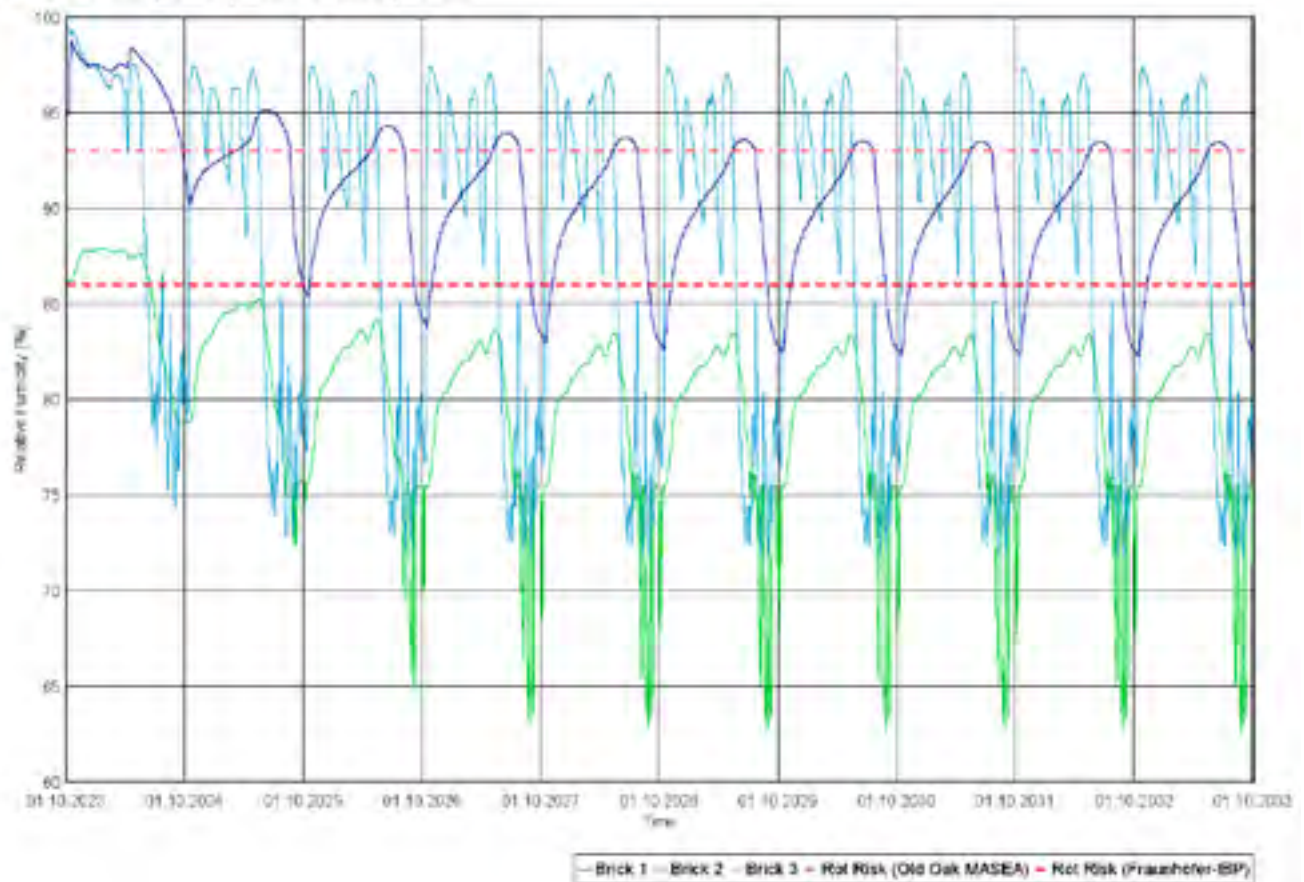
In the modelling case related to Brick 1, the threshold of 20% is exceeded for significant time periods regardless of the timber type. In the modelling case related to Brick 2, the threshold of 20% is not exceeded only with a timber type with high moisture storage function, such as Oak, Old (MASEA). The modelling case related to Brick 3 showed that a brick type with low absorption, such as Brick 3, would prevent the risk of decay due to rot in the timber joist ends, regardless of the timber type.

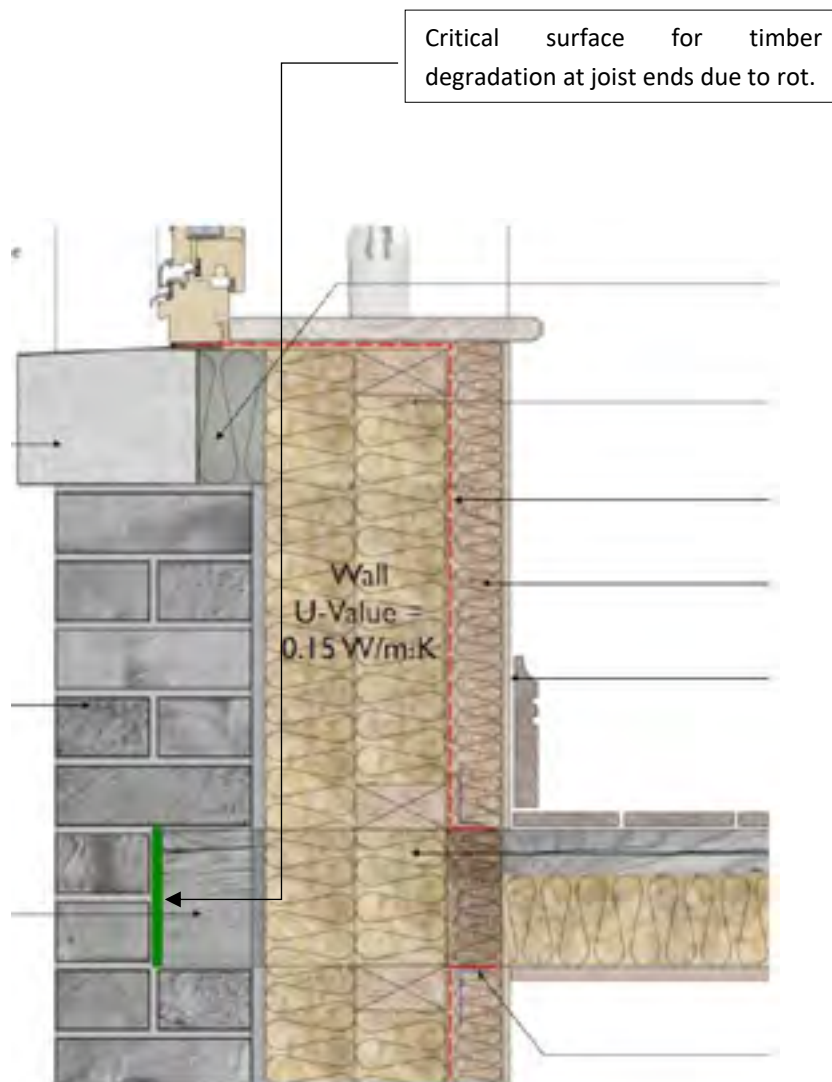
5.3 Assessment against freeze-thaw deterioration

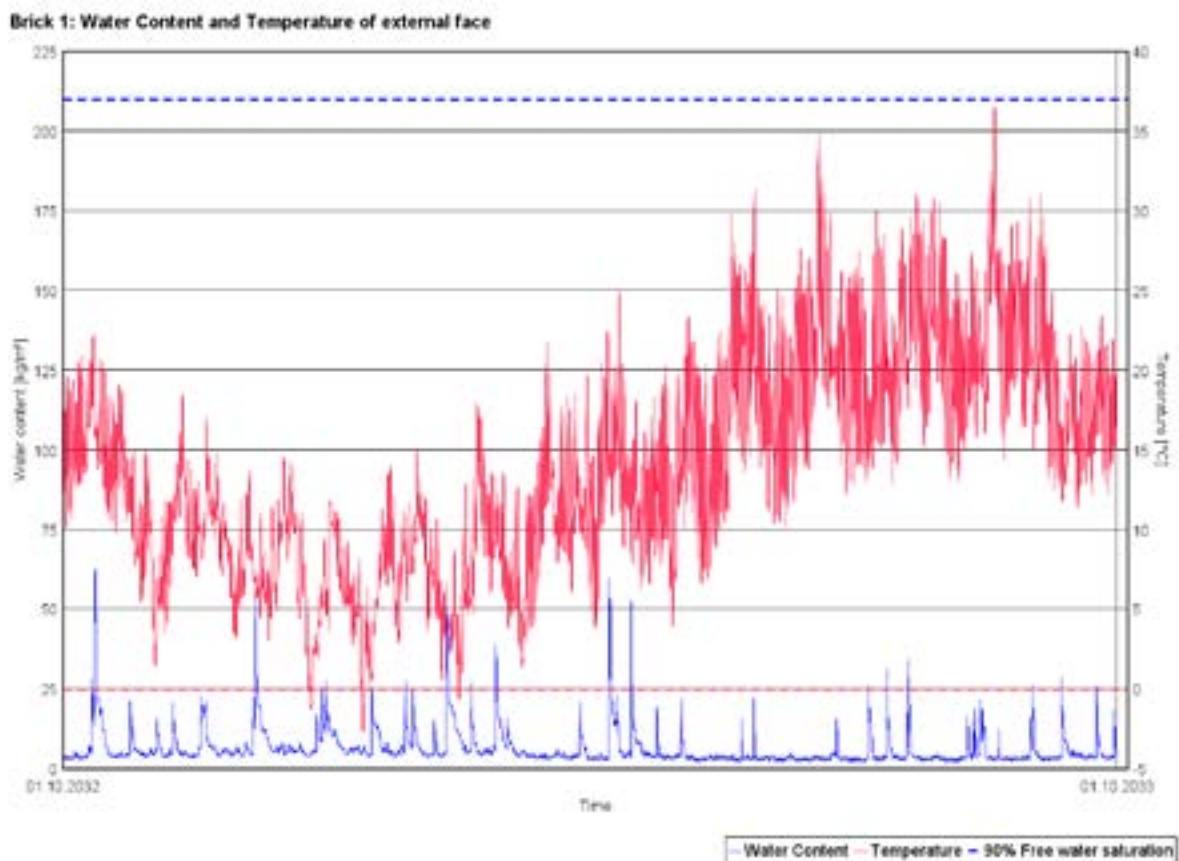
Brick 2: Water Content and Temperature of external face

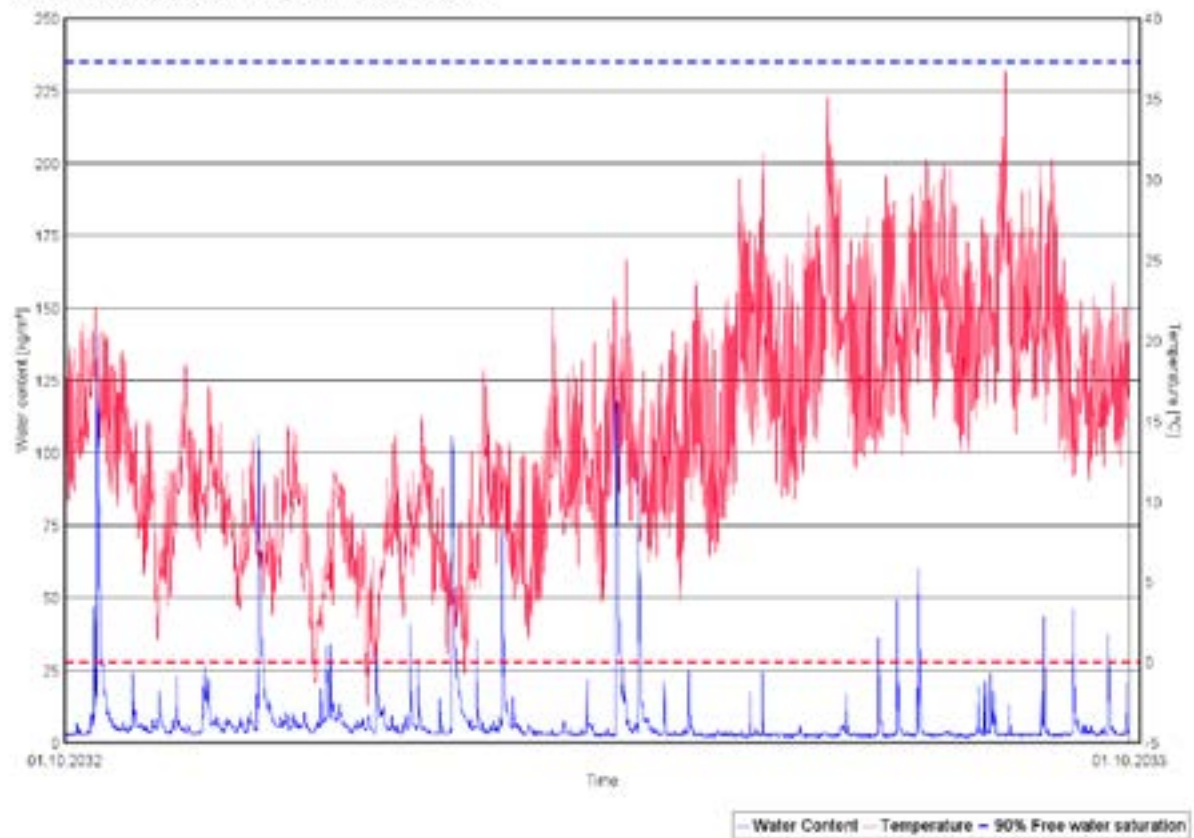
Brick 3: Water Content and Temperature of external face

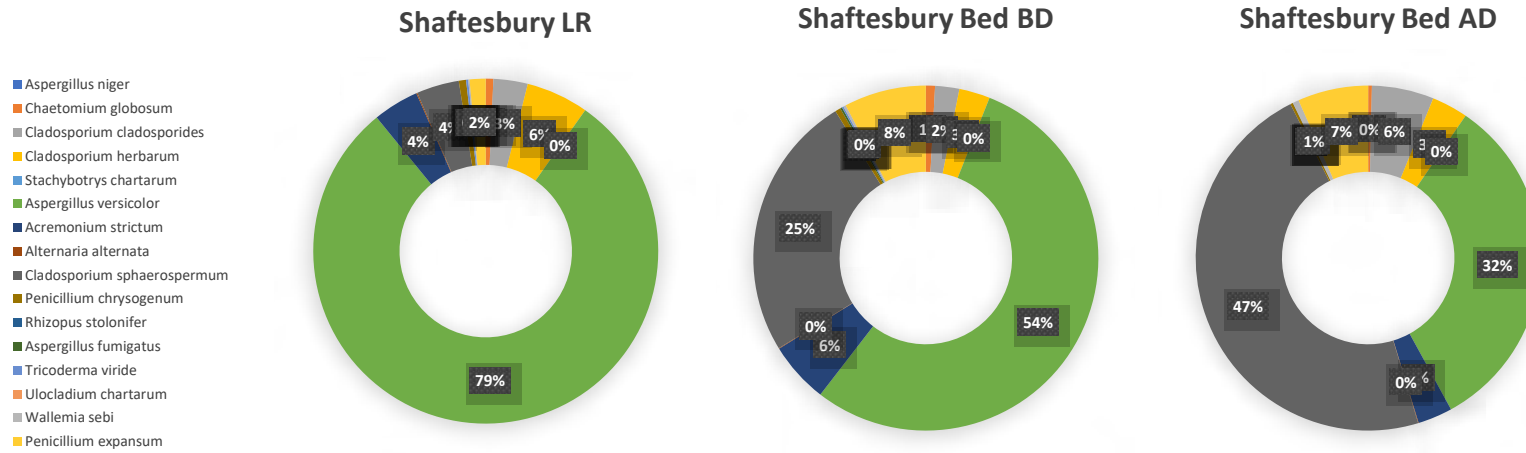
Figure 1: Percentage-wise distribution of the 16 fungal groups targeted in the rooms tested at the property located at Shaftesbury Park Terrace
